22kV cable termination, outer cone type

Asset: Cable lug of 22kV cable termination, outer cone type

PD sensor: Infra-Red thermal scan, ultrasound, TEV & HFCT

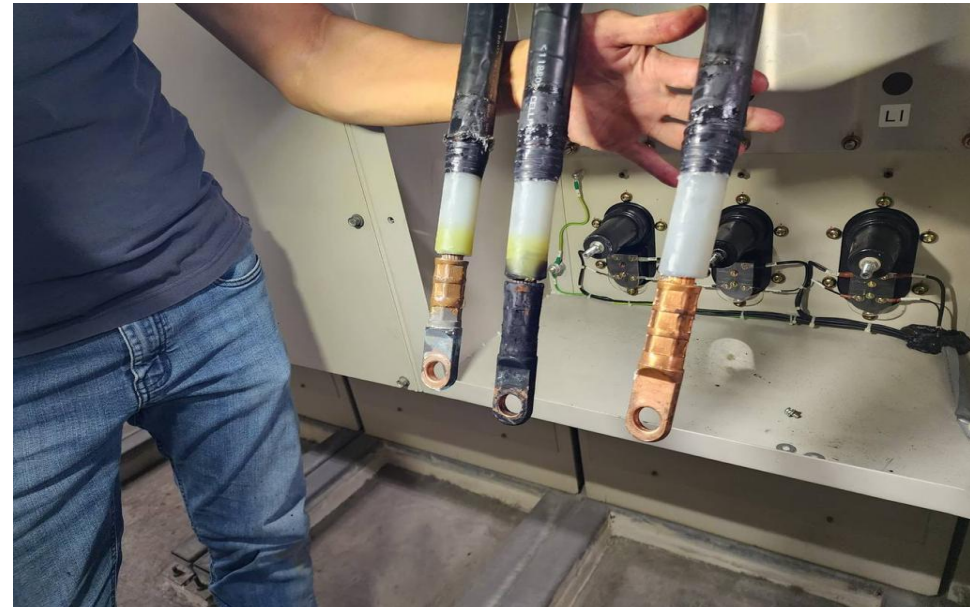
Visible discharge at Cable lug

29 November 2022 (0900 Hrs) PD activity was detected at 22kV cable termination of GIS using multiple PD sensor and Infra-Red thermal scanning.

29 November 2022 (2000 Hrs) The circuit was de-energized on the same day. PD was found at 22kV cable termination.

30 November 2022 Online PD re-measurement was done after replacement of cable terminations. No PD activity found.

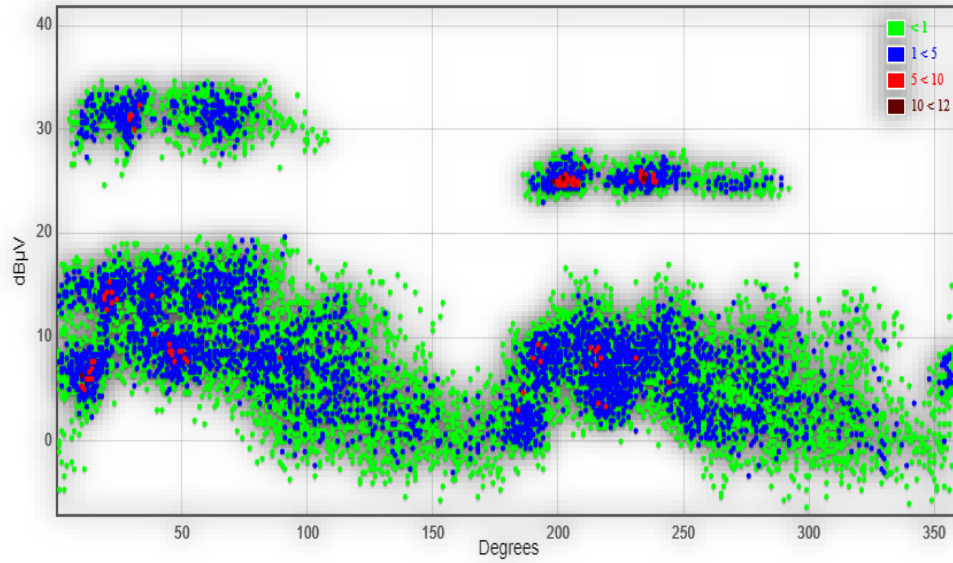
Abnormal ultrasound

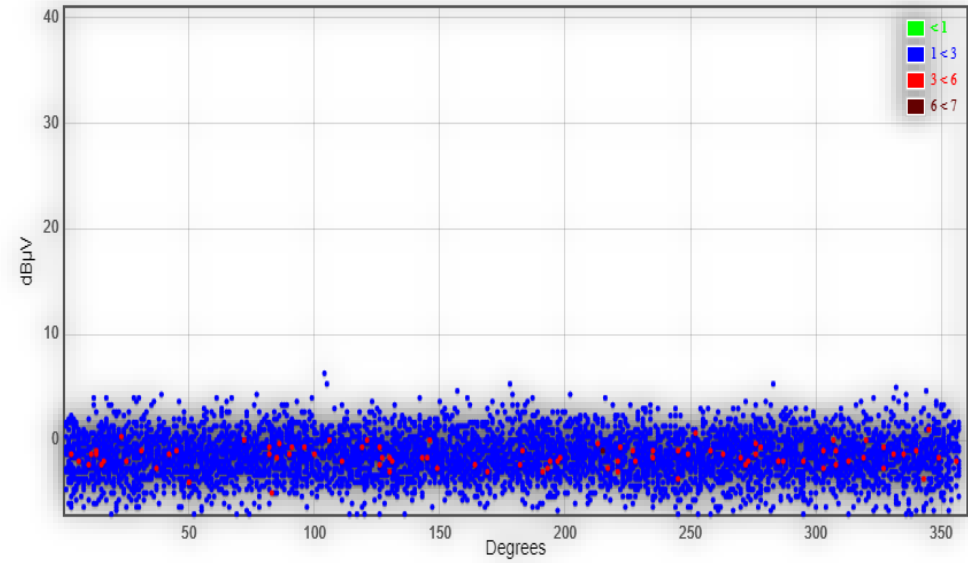
No abnormal ultrasound after replacing of cable termination

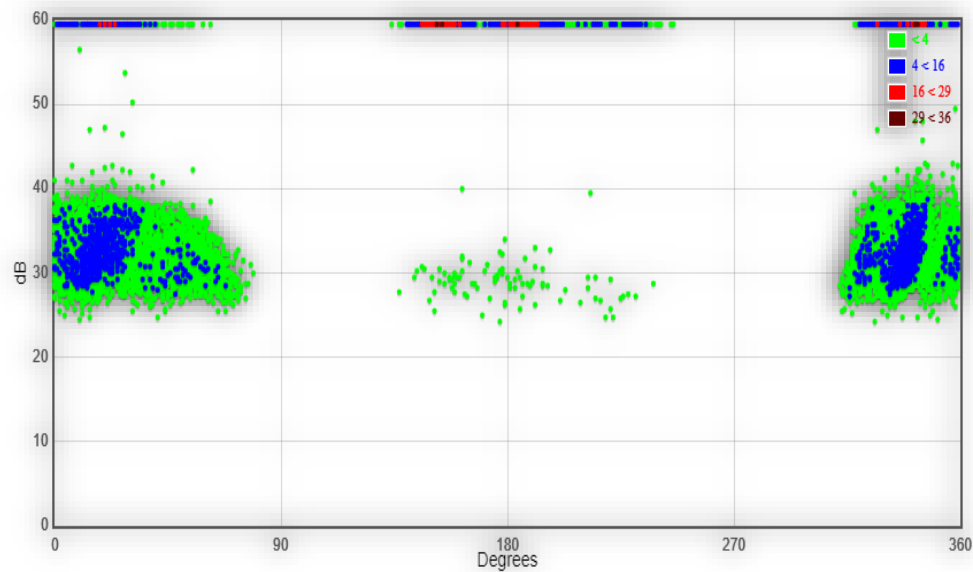
PD detected

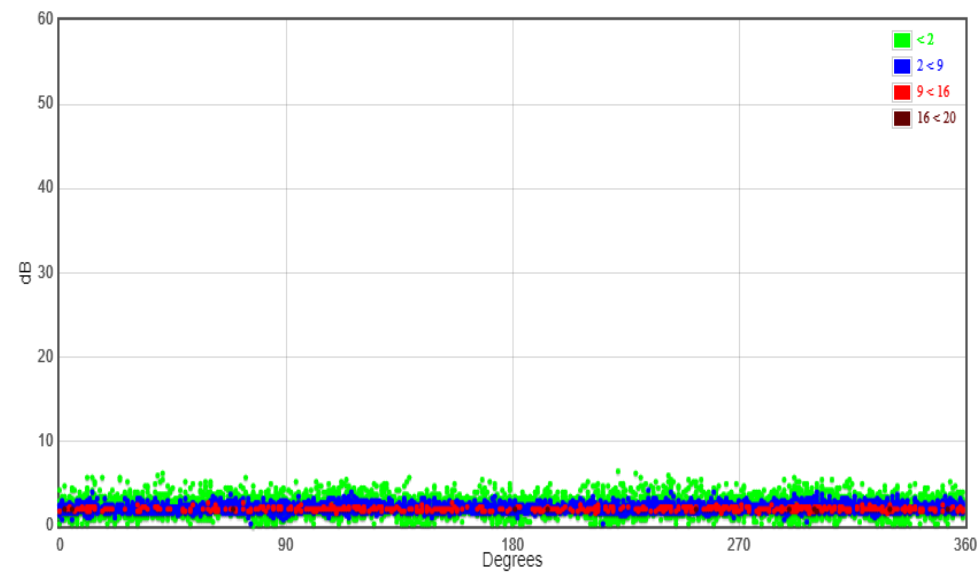
No PD detected after replacement of cable termination

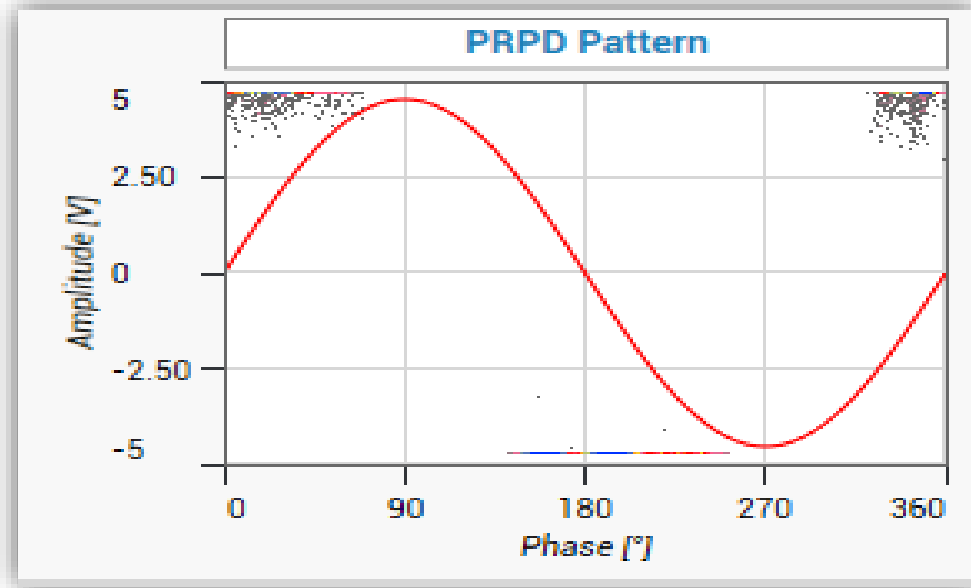
High PD detected at 5 volts magnitude

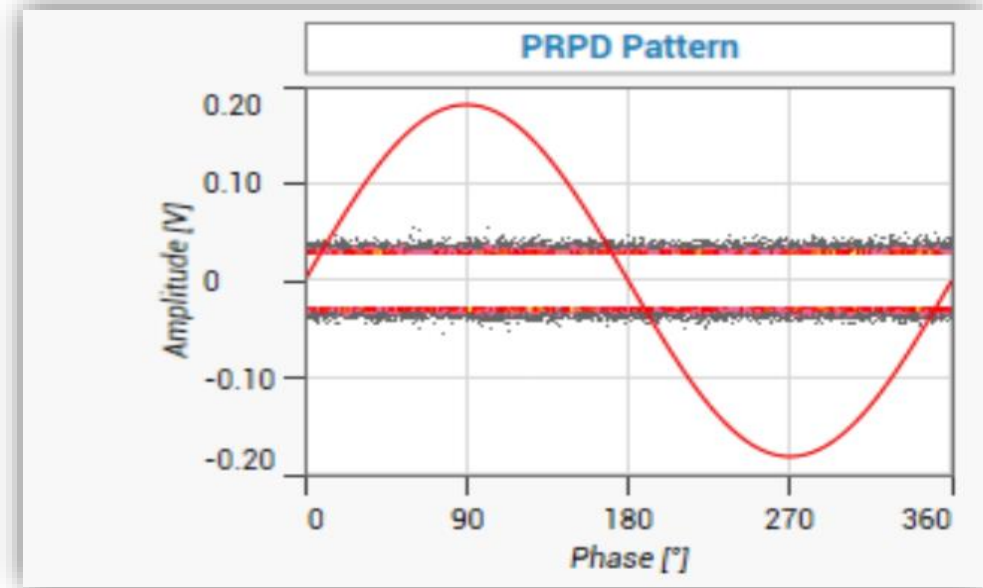
No PD detected after replacement of cable termination

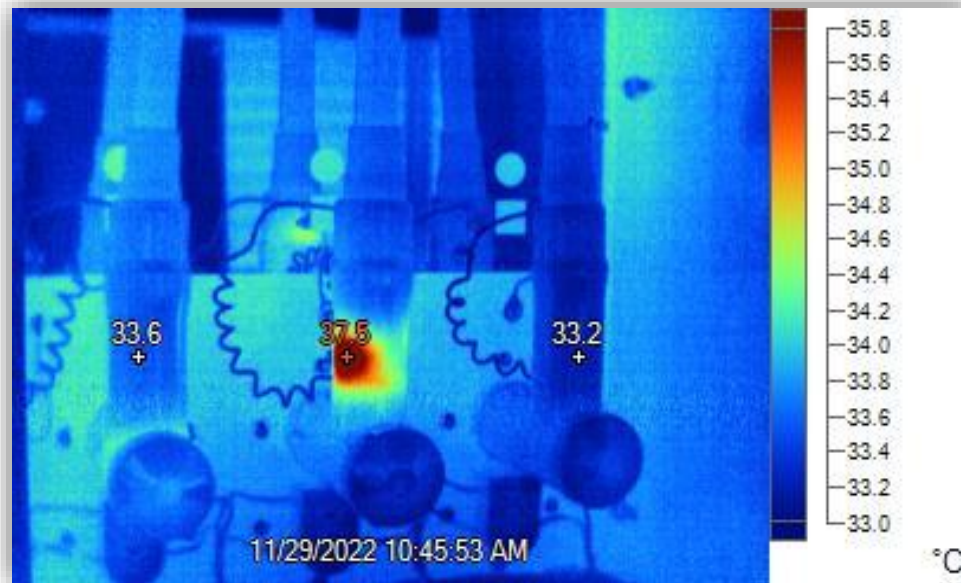
Thermal Abnormality detected

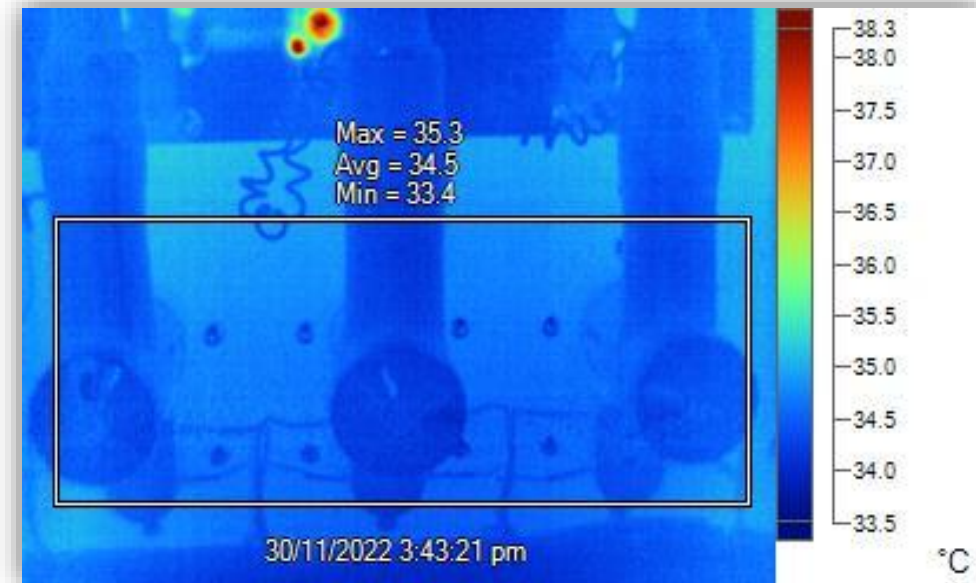
No Thermal Abnormality detected after replacement of cable termination
