22kV cable termination, outer cone type

Asset: Insulating body of 22kV cable termination, outer cone type

PD sensor: Ultrasound & TEV

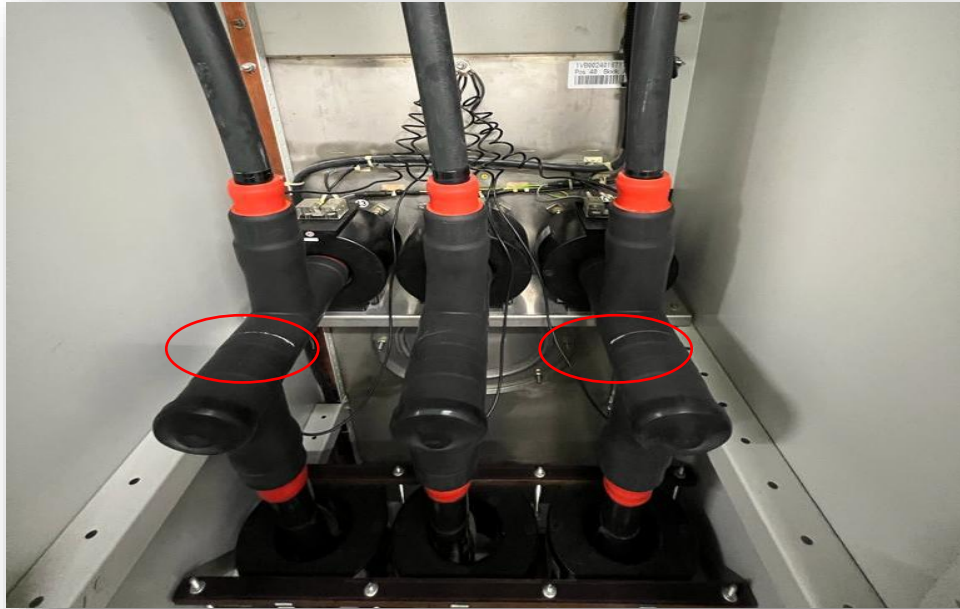
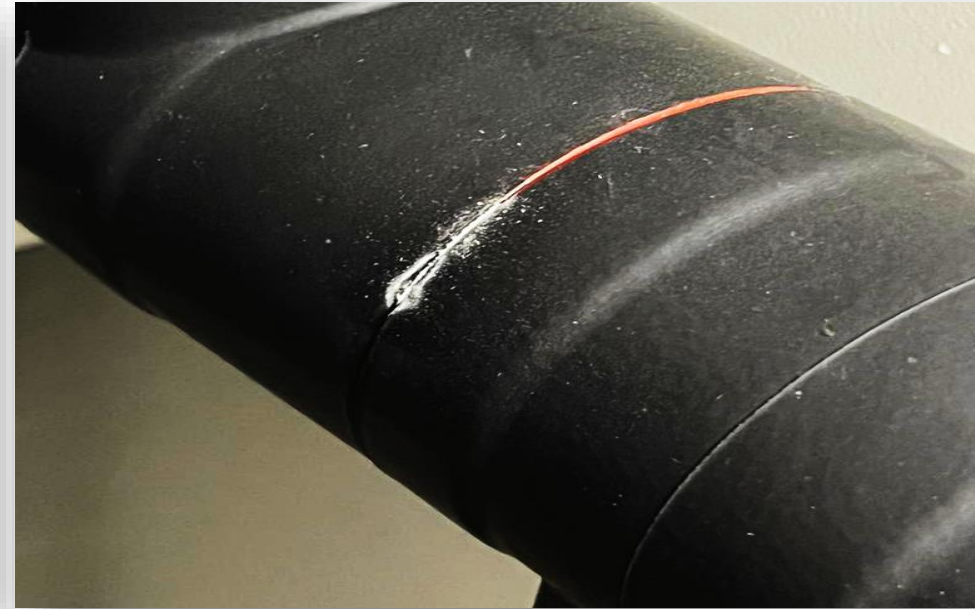
Visible cracks at Insulating body

15 June 2022 GIS was de-energized. Visible cracks were found at the cable termination.

15 June 2022: No abnormalities were detected after replacement of the cable terminations.

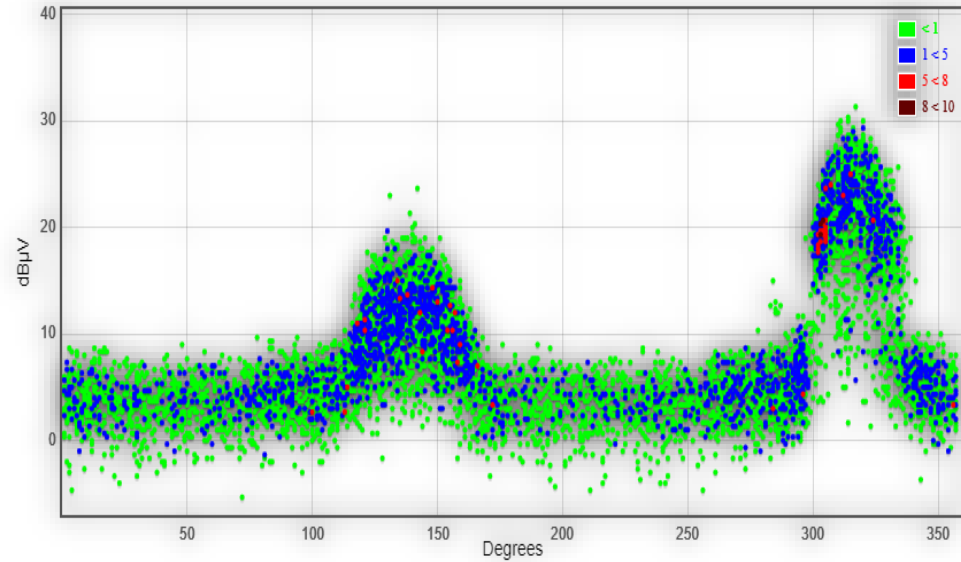
24 May 2022 PD activity was detected using airborne ultrasound sensors, Infra-red Thermal scanning and TEV sensor at back panel of GIS.

Abnormal Ultrasound

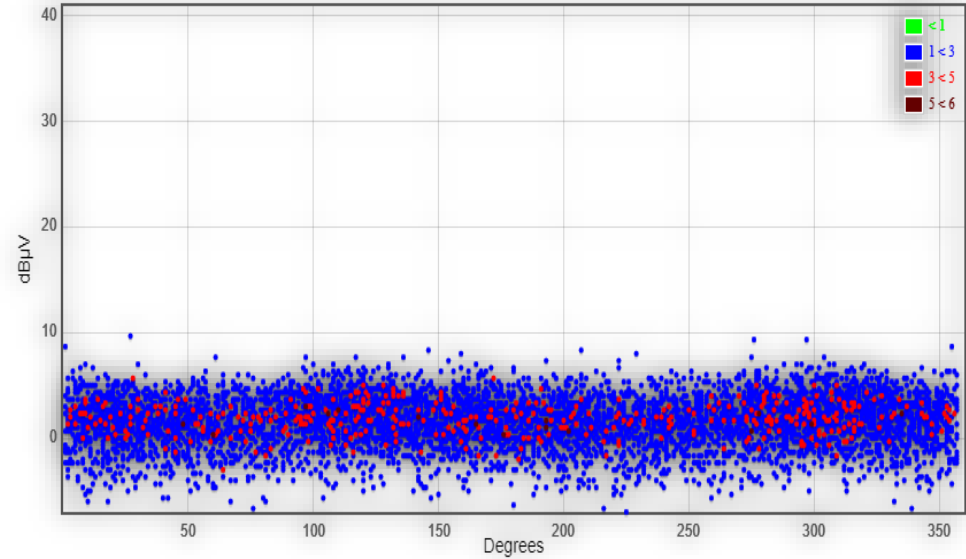
No abnormal ultrasound after replacement of cable termination

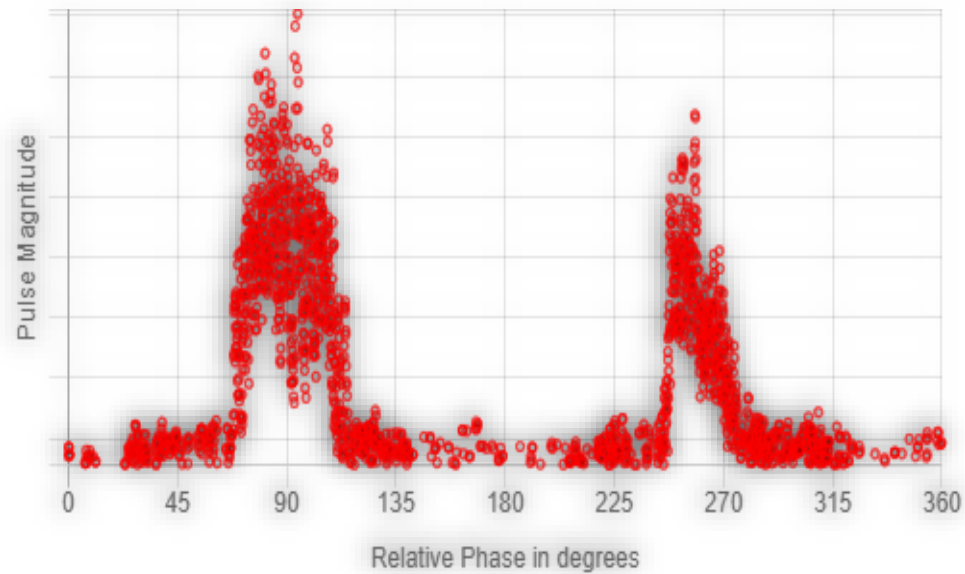
Abnormal Ultrasound

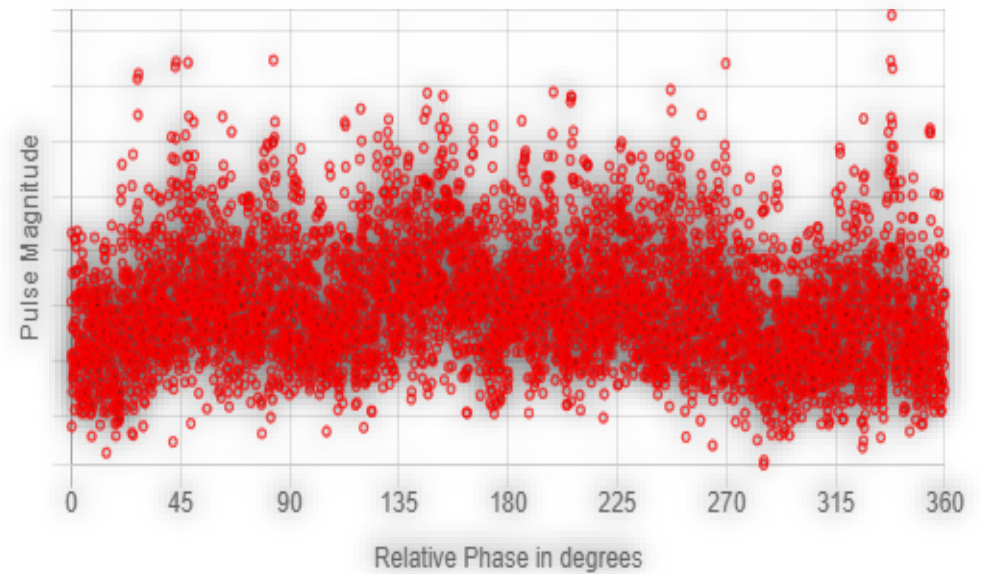
No abnormal ultrasound after replacement of cable termination

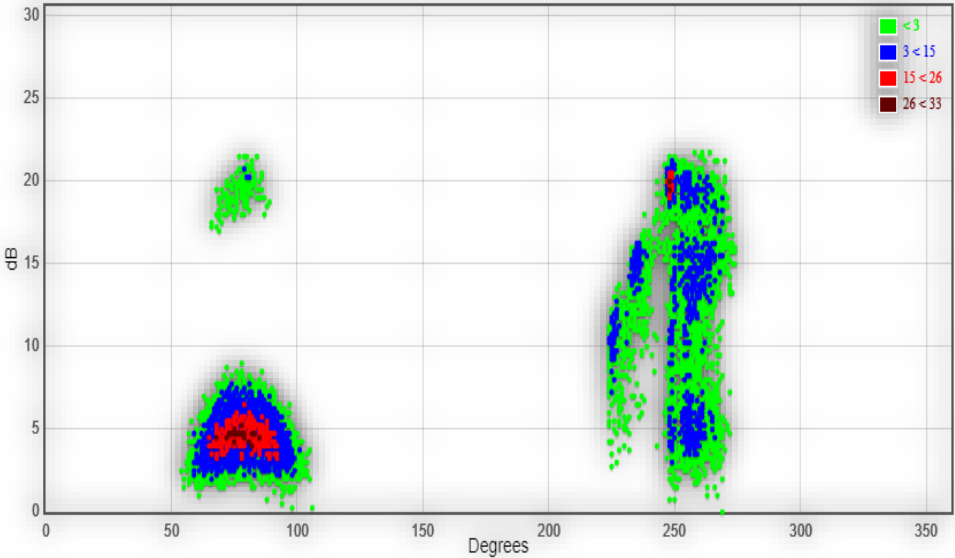
PD detected

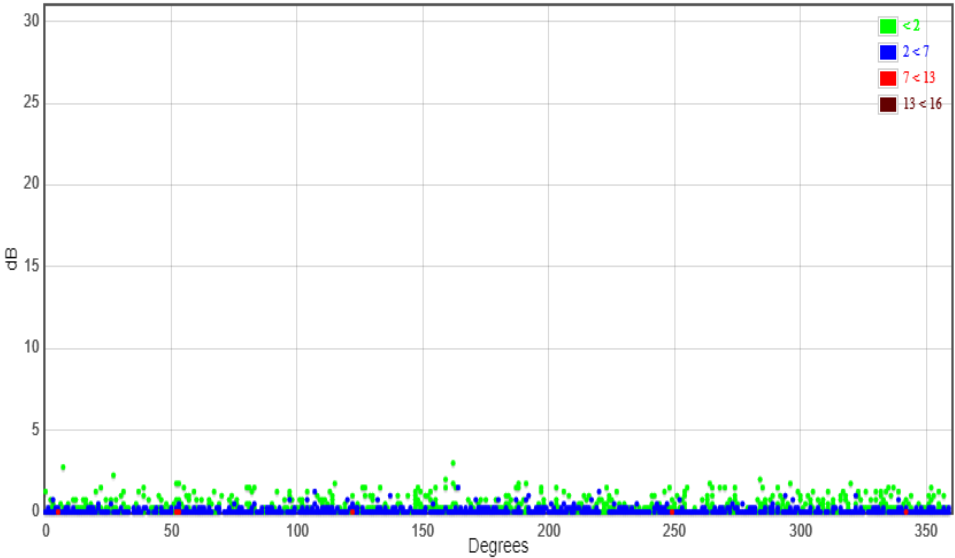
No PD detected after replacement of cable termination
