22kV/433V Dry type transformer

Asset: 2MVA, 22kV/433V Dry type transformer

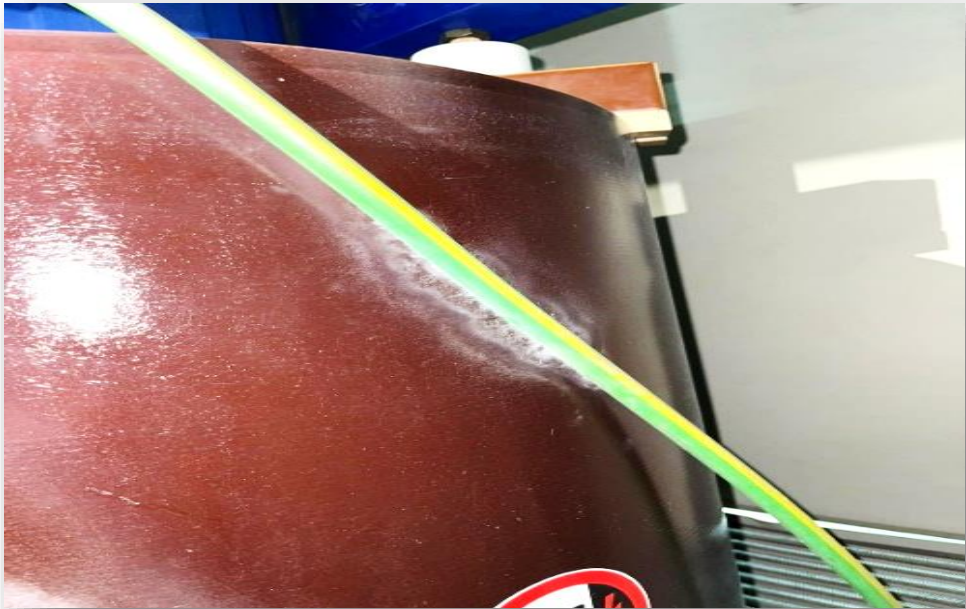
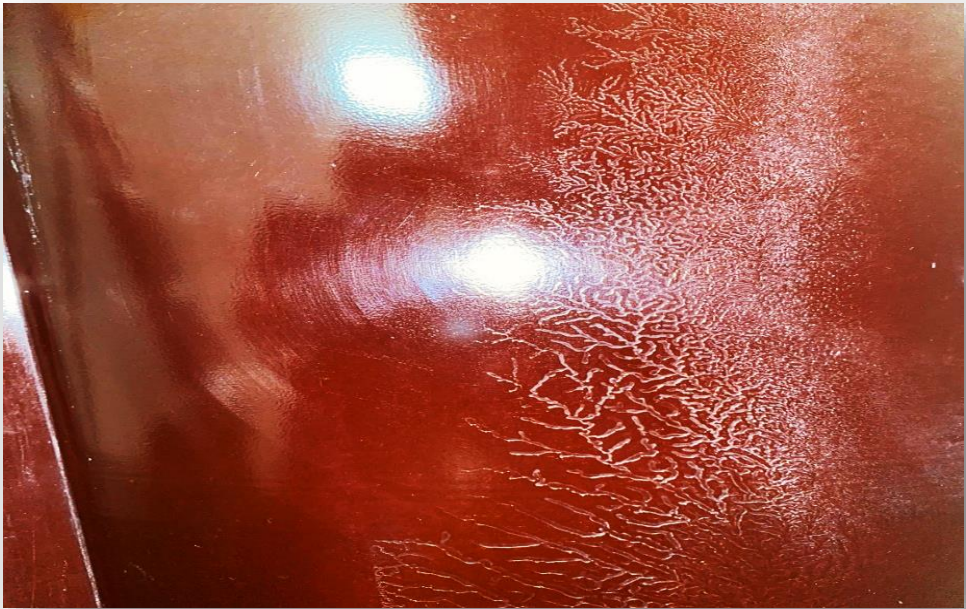
Visible discharge at 22kV windings

04 September 2021 The transformer was de-energized. Earth cable was found touching to transformer winding and electrical discharge was found at the surface of 22kV windings.

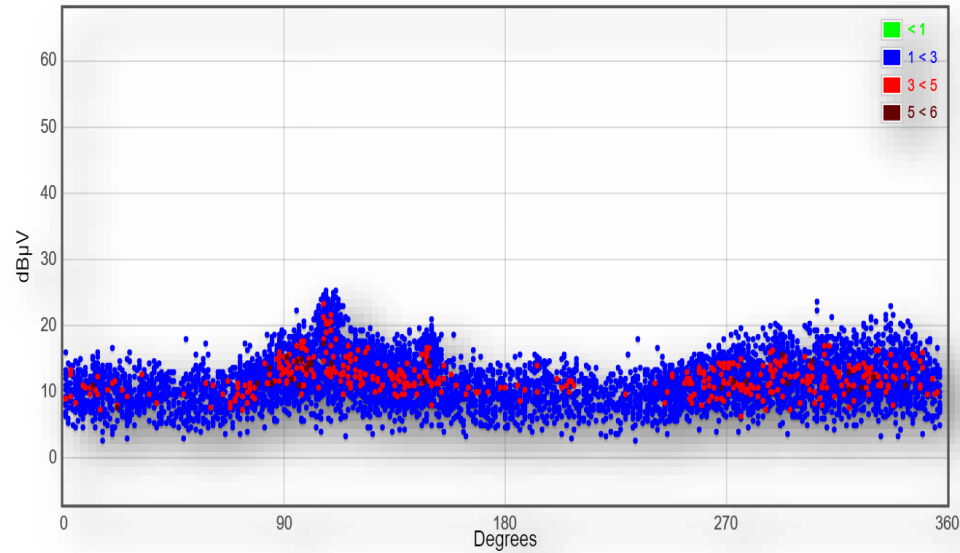
Abnormal Ultrasound

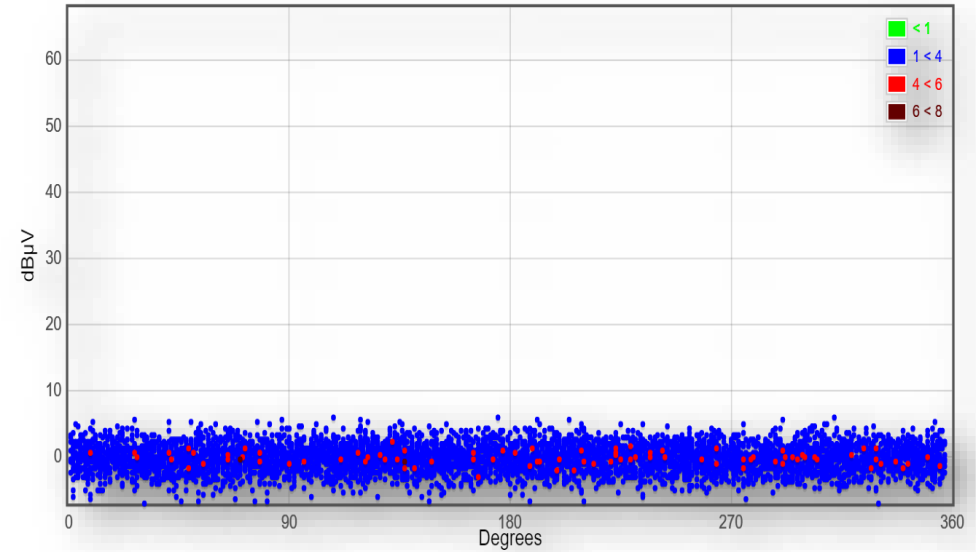
No abnormal ultrasound after rectification

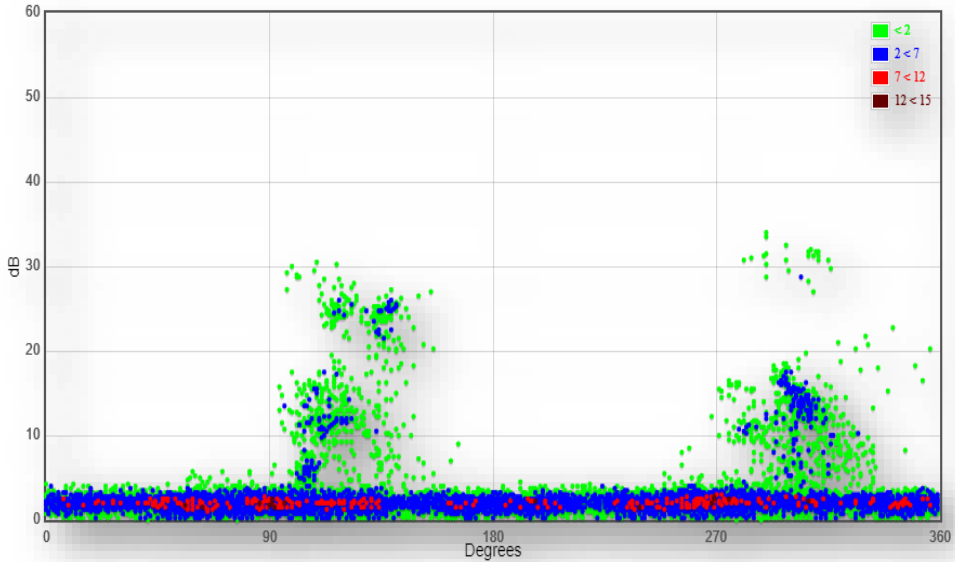
PD detected

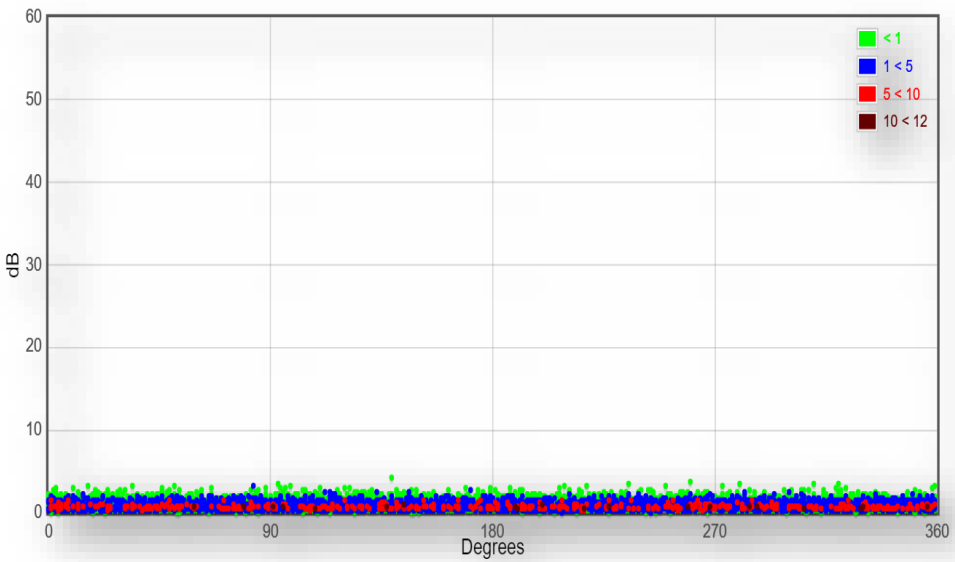
No PD detected after rectification

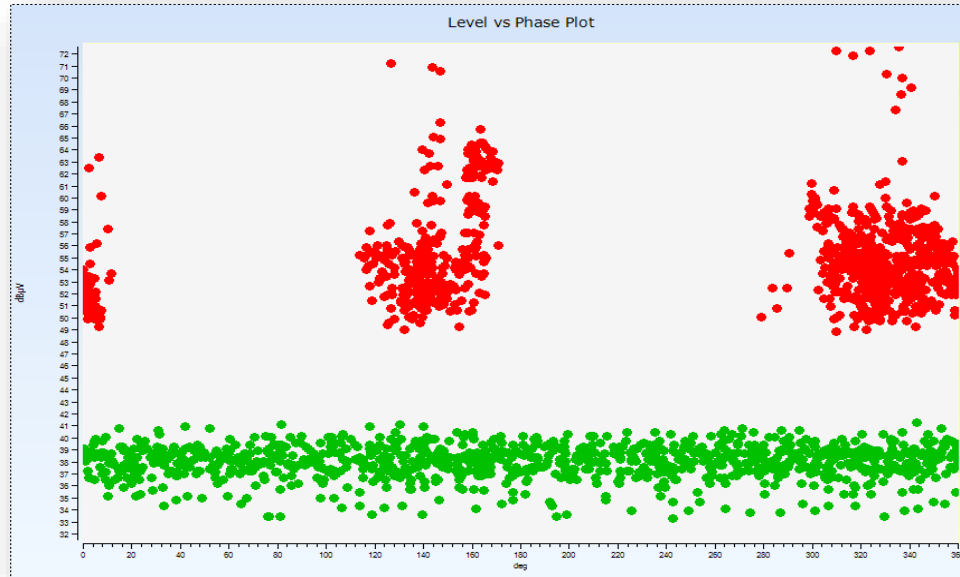
PD detected

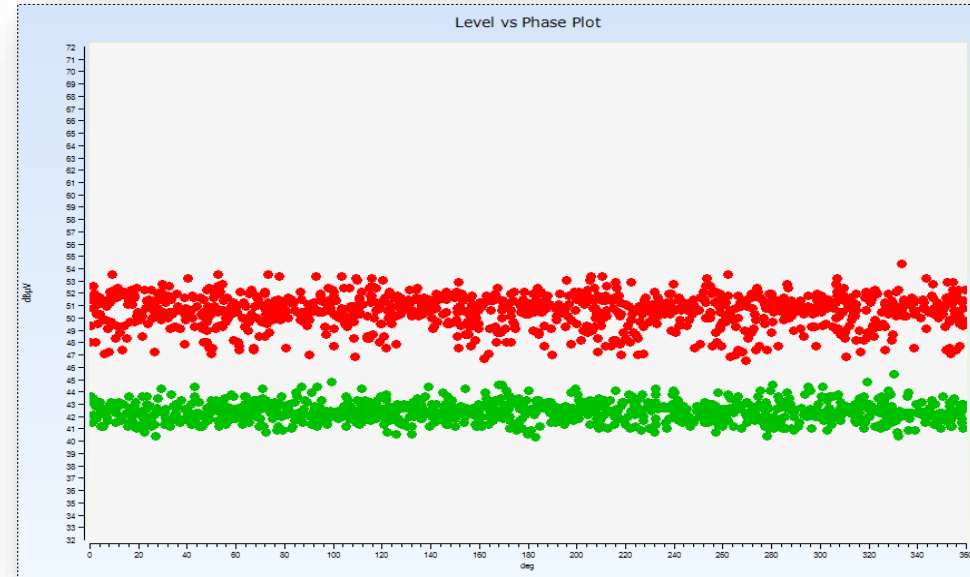
No PD detected after rectification
