Visible discharge at the cable lug of the 22kV Cable termination, outer cone type

Asset: 22kV cable termination, outer cone type

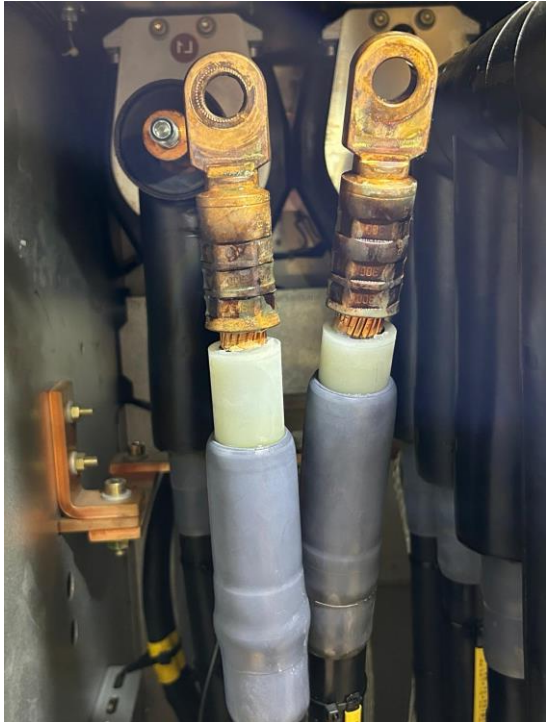
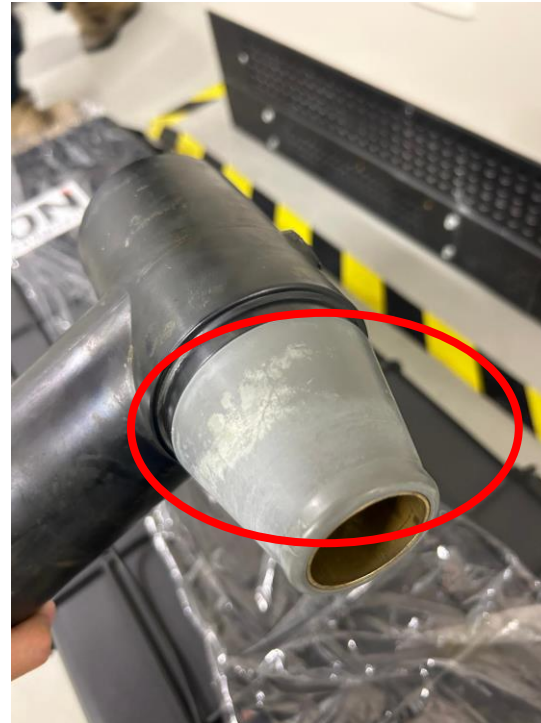
White residue due to hardened electrical grease.

14 May 2024 Circuit was immediately shut down.
Visible discharge was found at the cable lug of the termination.

16 May 2024 After rectification was done, no thermal abnormality and no PD detected.

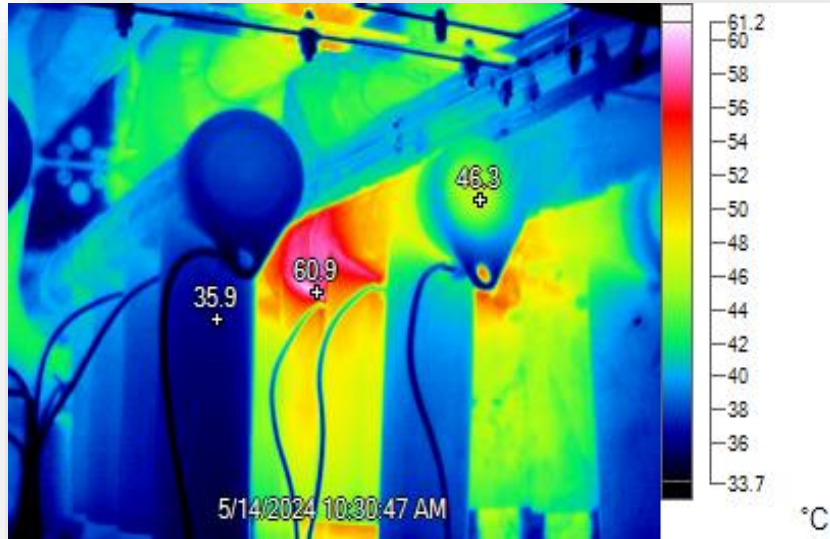
14 May 2024 Thermal abnormality detected, and PD detected by using TEV sensors.

Thermal abnormality was detected before rectification

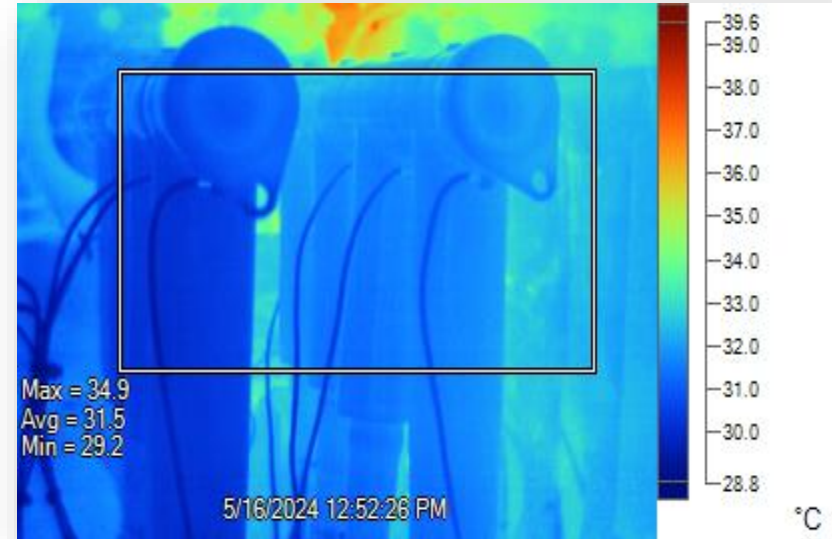
No Thermal abnormality after rectification

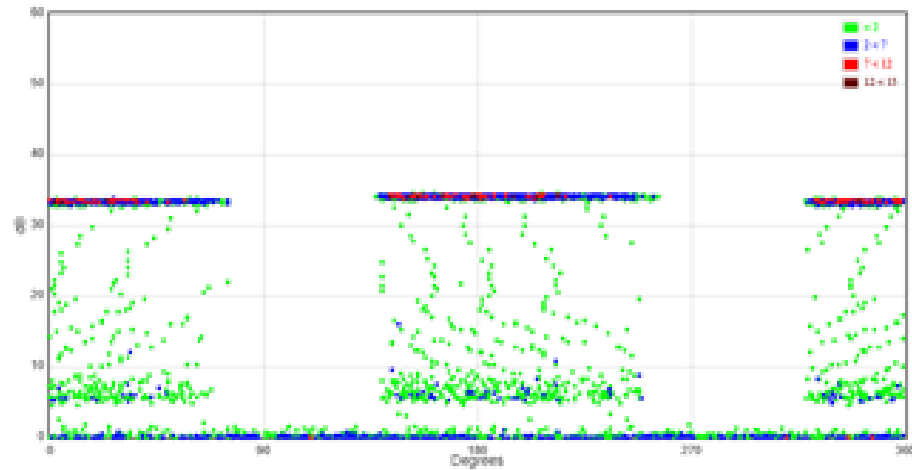
PD detected before rectification

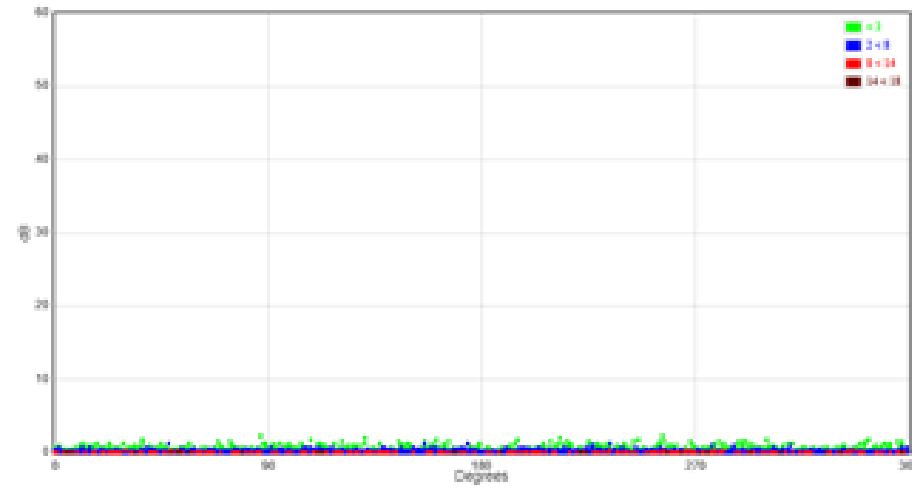
No PD detected after rectification
