Floating Potential detected and due to capacitive voltage tap of the 22kV cable termination not properly grounded.

Asset: 22kV Cable termination, inner cone type

PD sensor: TEV, Airborne Ultrasound

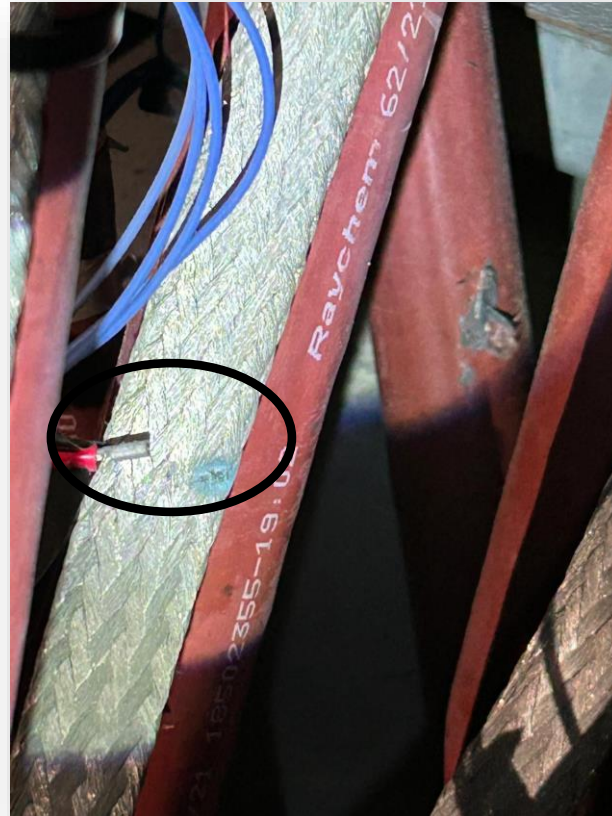
14 May 2024 Capacitive voltage tap of cable termination was found not properly grounded.

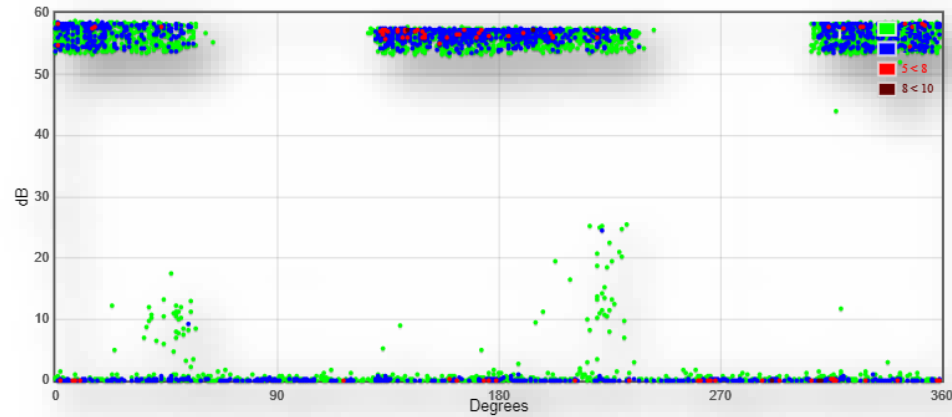
TEV: 59dBmV, 7.34ppc

High magnitude PD detected before rectification

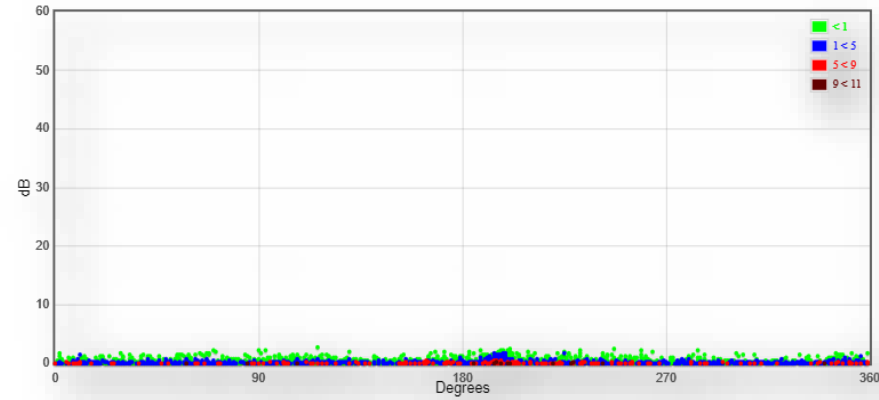
TEV: 2dBmV, 0ppc

No PD detected after rectification

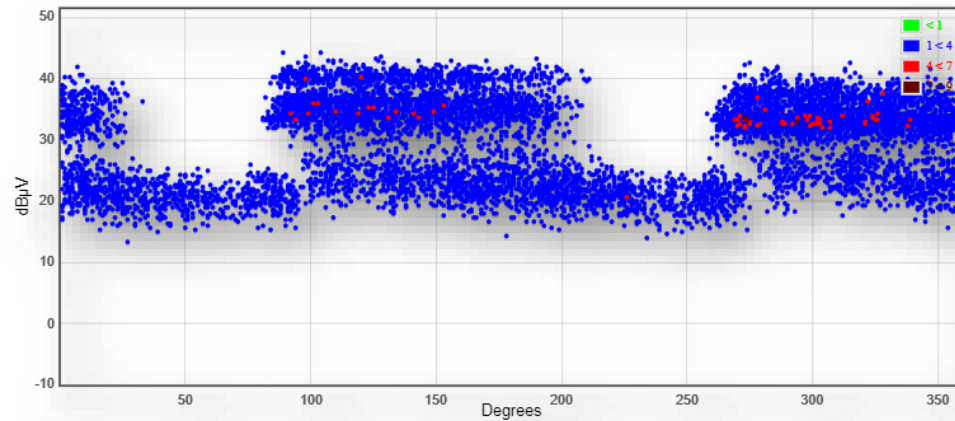
Airborne Ultrasound: 31dB μ V

Abnormal Ultrasound detected before rectification

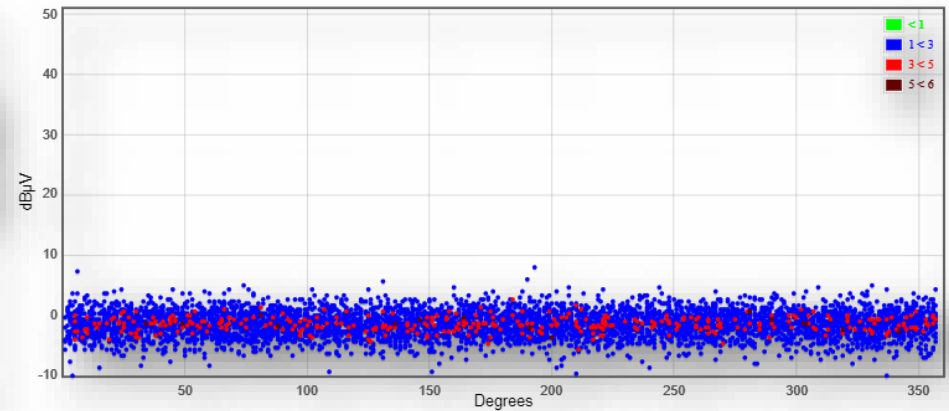
Airborne Ultrasound: -2dB μ V

No Abnormal Ultrasound after rectification

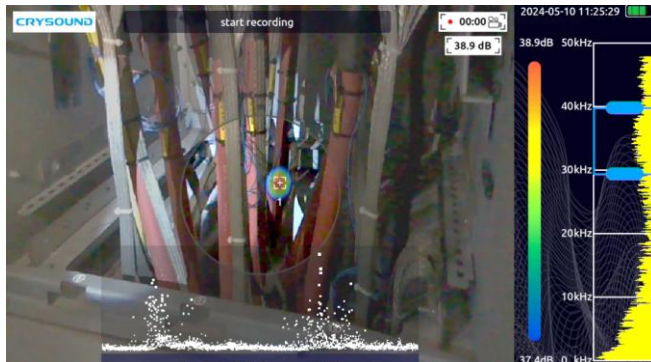
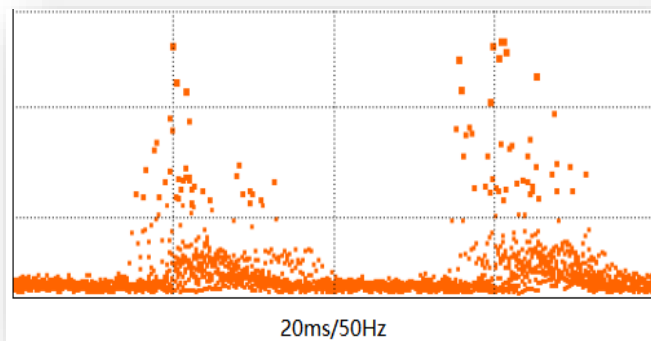
Airborne Ultrasound: 39dB μ V

Abnormal Ultrasound detected before rectification

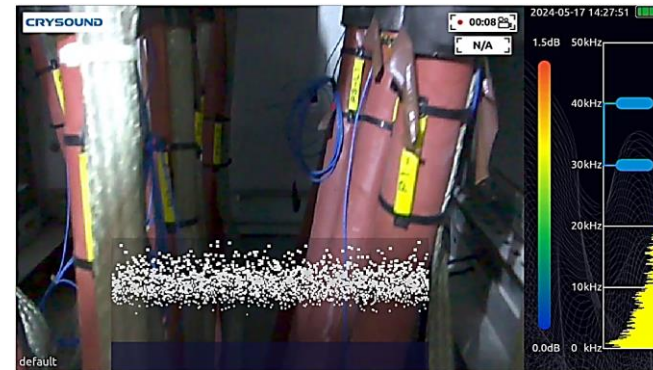
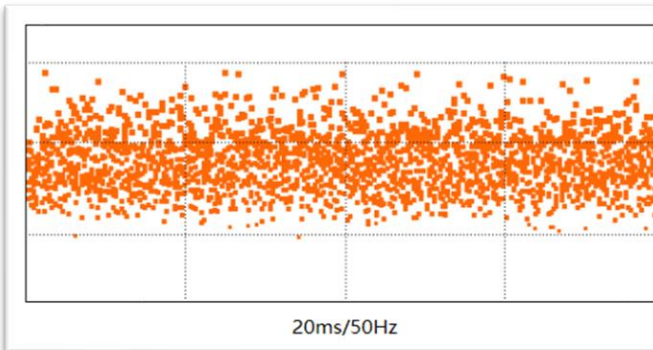
Airborne Ultrasound: 2dB μ V

No Abnormal Ultrasound after rectification
