Visible discharge at the 22kV AIS

| Asset: | 22kV AIS Bus bar connector between CT and cable termination |

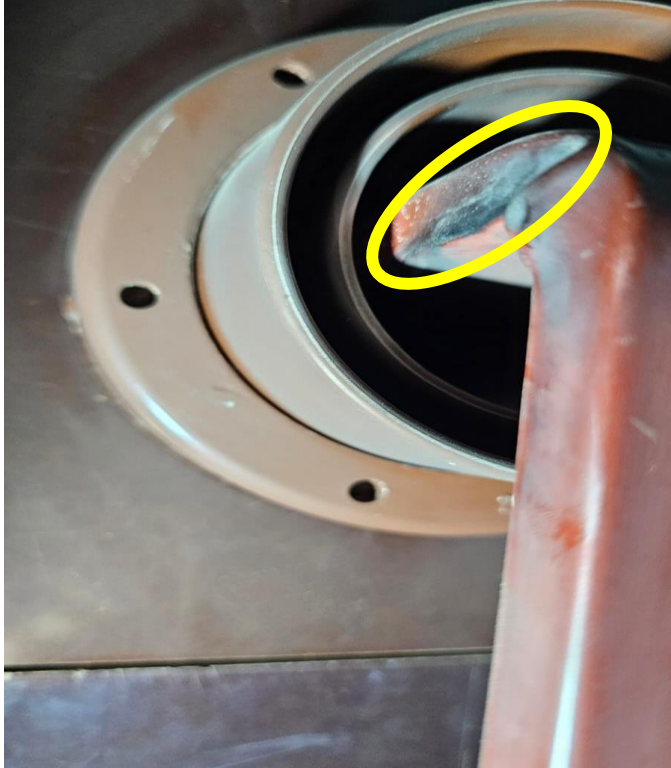
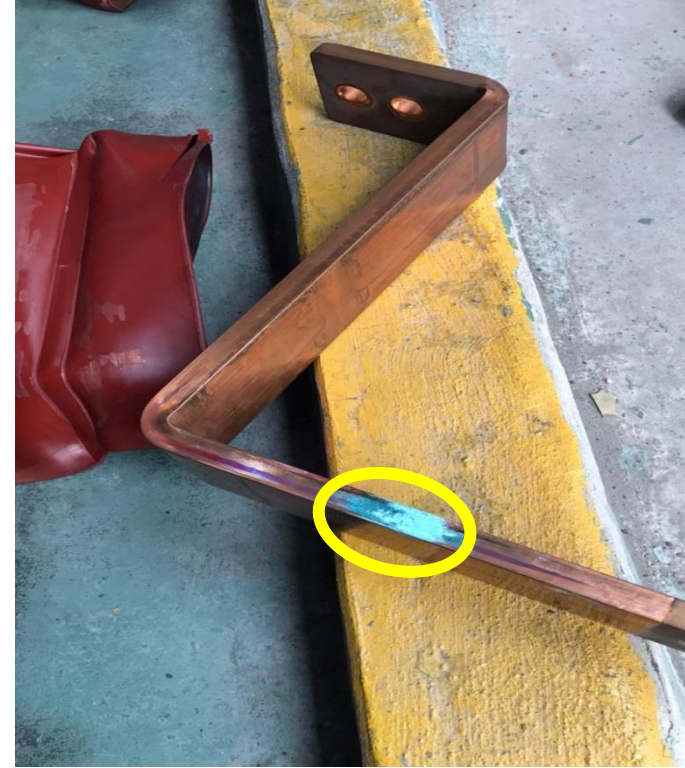
| 21 September 2024 | Circuit was de-energized. Visible discharge was found at bus bar connector. |

| 23 September 2024 | After rectification was done, no PD detected. |

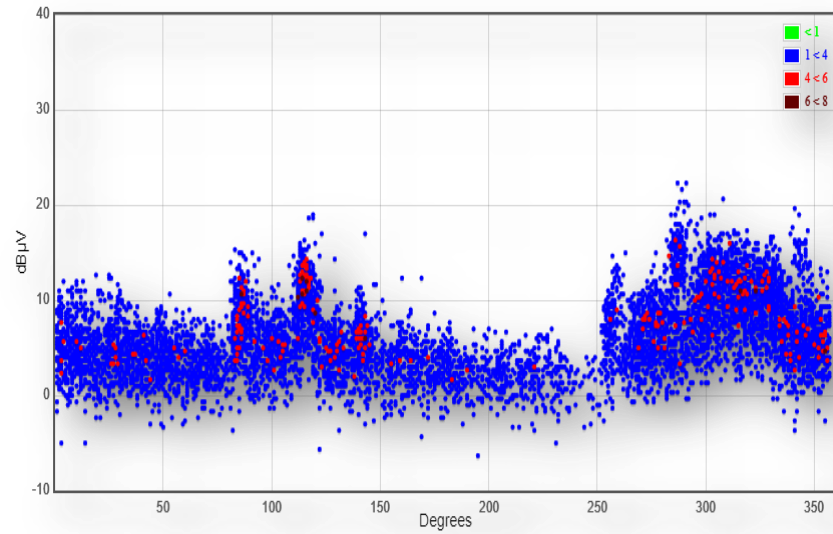
Abnormal ultrasound detected

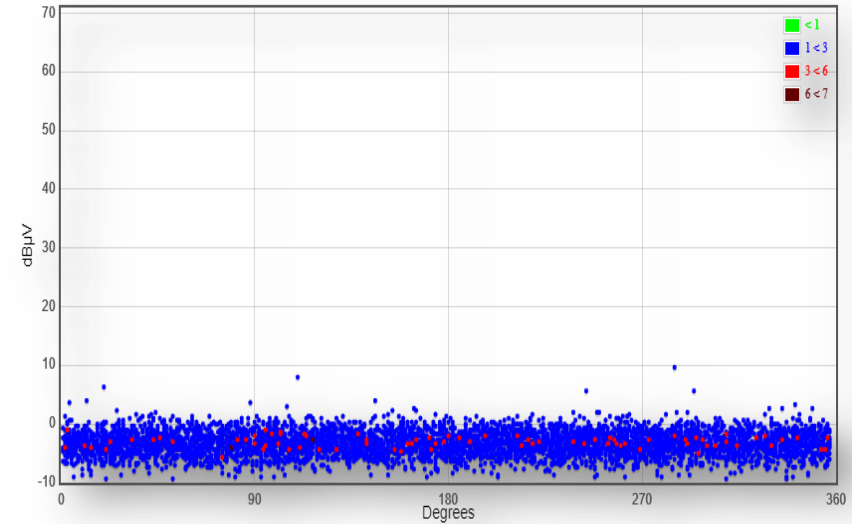
No Abnormal ultrasound detected after rectification

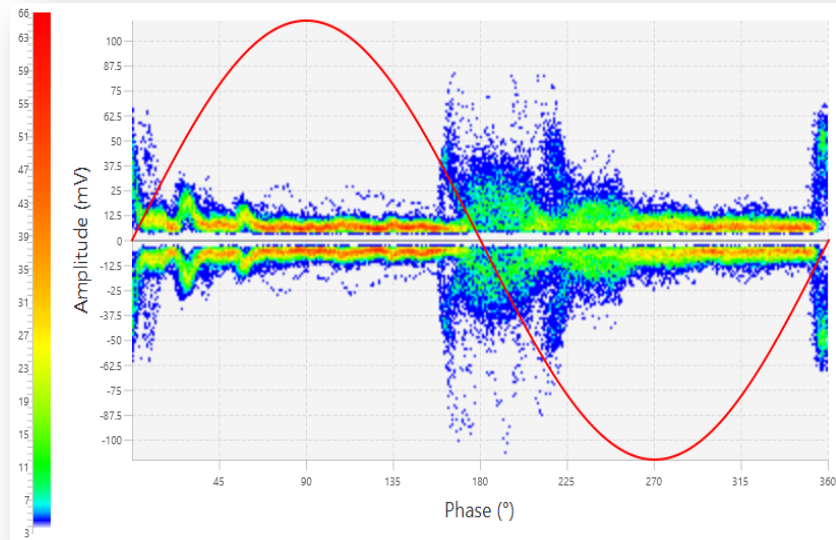
Abnormal ultrasound detected

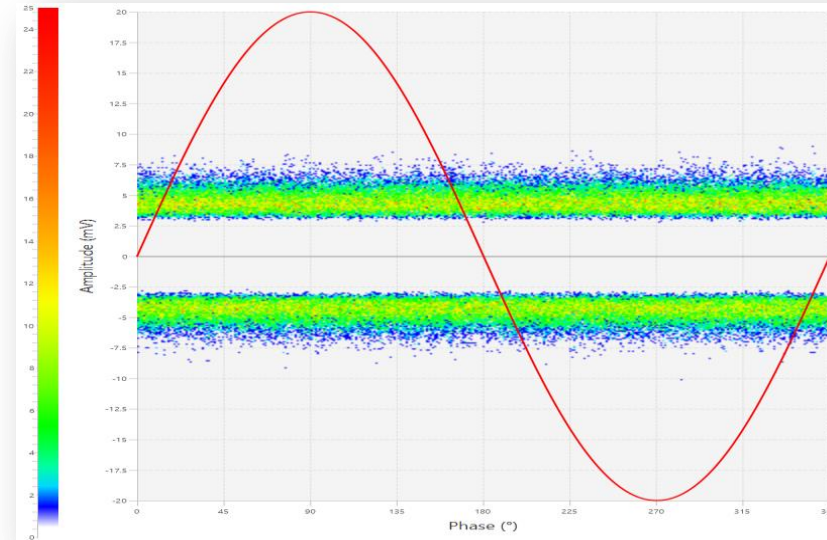
No Abnormal ultrasound detected after rectification
