The use of multiple sensors, of electrical and non-electrical type, for online PD measurement of cables , transformers, switchgears and motors

LEE WAI MENG
ELECTRICAL PE/LEW (230KV GRADE)

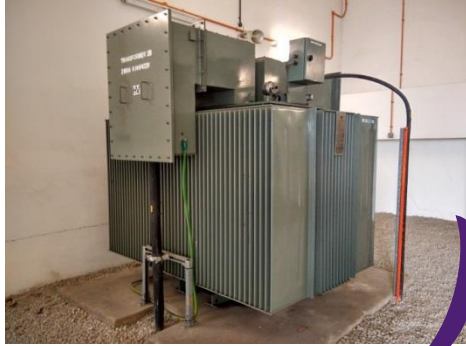
Online Airborne Ultrasound Measurement

- Sound waves beyond the hearing range of the human ear.
- Audio Sound Waves
 - In the range of human hearing (20Hz to 5000Hz).
- Airborne Ultrasound Waves
 - Frequency above the audible range(20kHz to 40kHz).

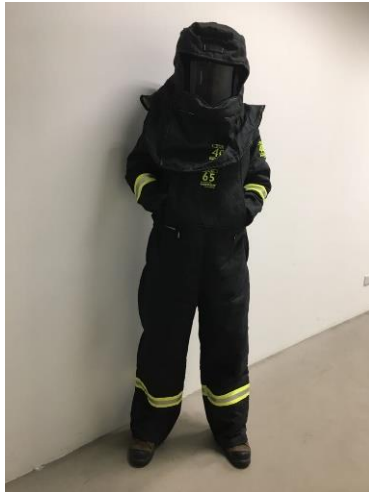
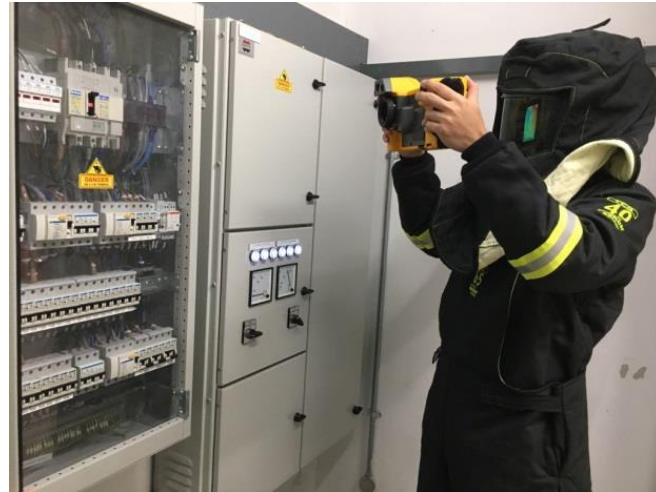
Infrared Thermography

- To find hot spots caused by defects in connections and components.
- To inspect electrical equipment because excess heat is usually the first sign of trouble.

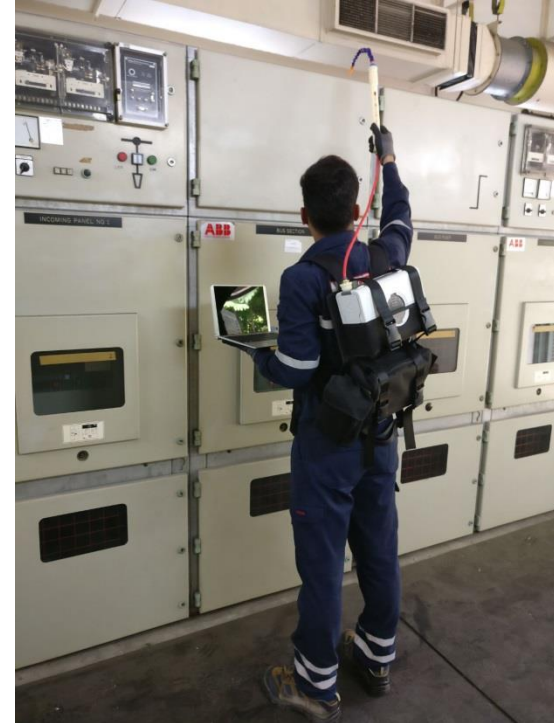
Smoke Particles Measurement

(Portable Smoke detector)

- Suitable for AIS, Transformer Cable box , LV switchboard

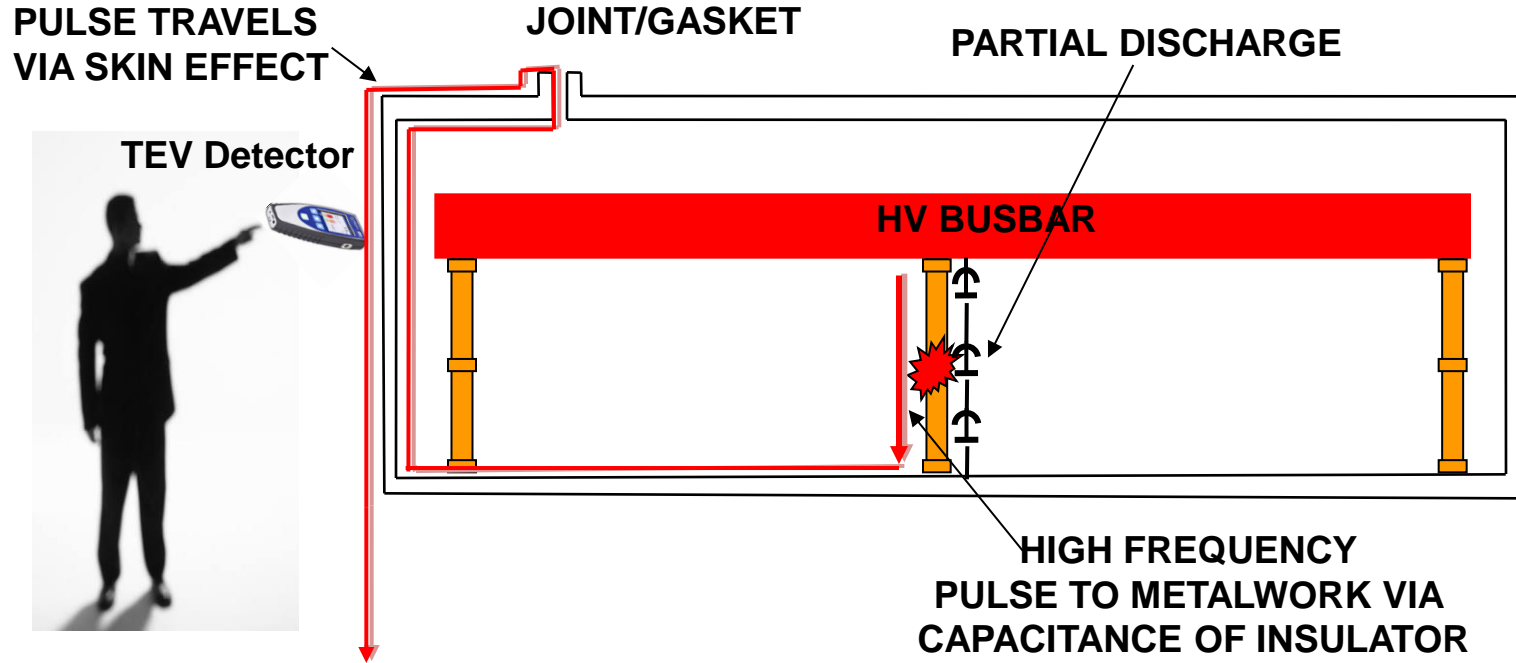
Principal of Transient Earth Voltage Detection

- TEV = Transient Earth Voltage
- Capacitive couplers placed at external metal surface of electrical equipment using a magnet
- Pulse Width – A few tens of nanoseconds
- Bandwidth = $\frac{1}{10 \text{ nanoseconds}}$
= 100 MHz

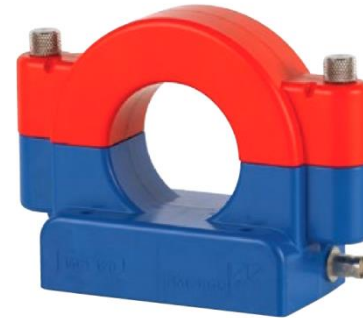
Split core type HFCT sensor

- HFCT = High Frequency Current Transformer
- Does not respond to 50Hz current
- Frequency range of 100kHz to 25MHz
- Soft ferrite range
- Split core construction

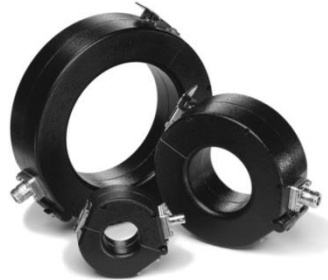
Inductive type UHF Sensor
100 MHz – 450MHz
10MHz – 200MHz

- UHF = Ultra High Frequency
- Response frequency range - 300 MHz to 3,000 MHz
- To detect PD fault that are closer to the sensor location. For instance; UHF sensor is used to detect PD at cable termination.

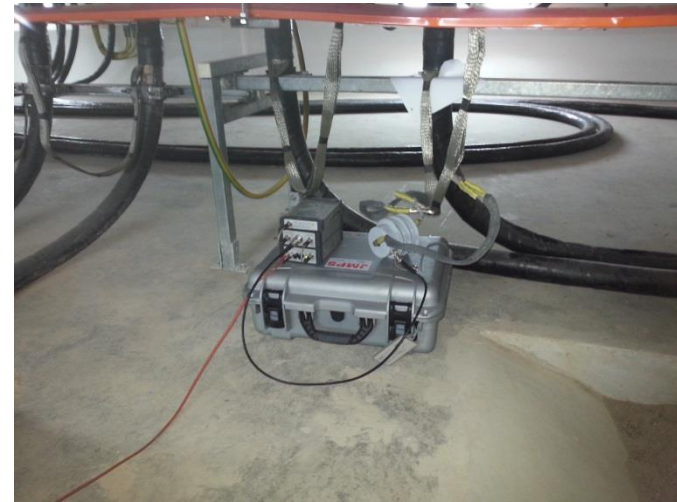
To detect PD fault that are closer to the sensor location

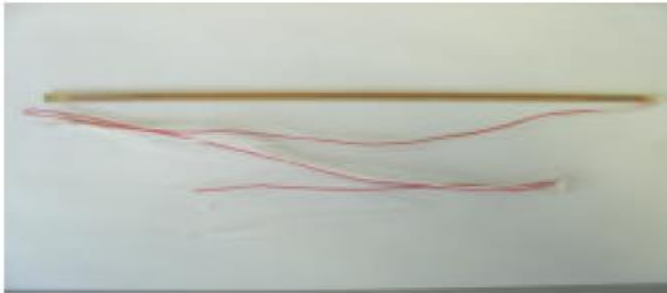
Resistance Temperature Detector (RTD) as Embedded PD Sensor

- RTD = Resistance Temperature Detector
- Temperature sensor that contain resistor that change resistance value as temperature changes
- Act as antenna type PD Sensor to detect defects in stator winding

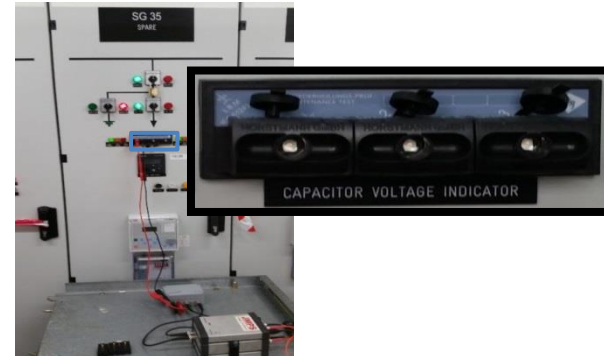
Voltage Detection System (VDS) as Embedded PD Sensor

- VDS = Voltage Detection System
- Devices used to detect the presence or absence of operating voltage.
- Act as antenna type PD Sensor to detect defects at the cable termination

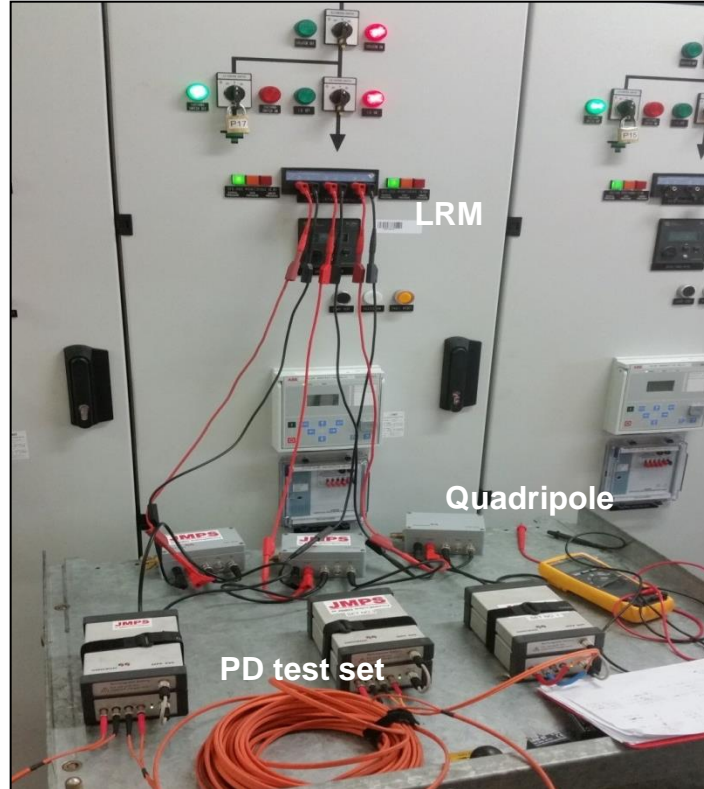
Online PD Measurement Using VDS as Embedded PD Sensor

ABB GIS

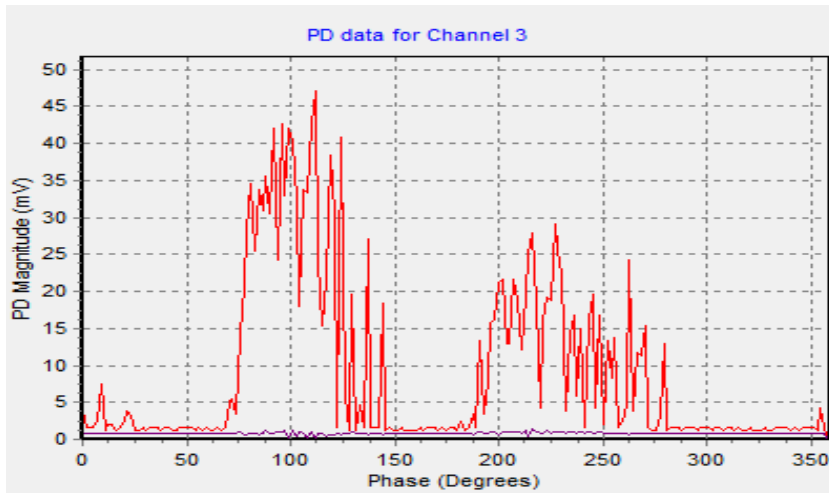
Phase Resolved TEV
Transformer 001

- Device Under Test (DUT):
 - **2.5MVA 22kV/420V Oil type Transformer at a Chemical Plant in Jurong Island**
- Type of Partial Discharge Sensor Used:
 - **Airborne Ultrasonic sensor**
 - **TEV sensor**
- Date:
 - **29th January 2016**

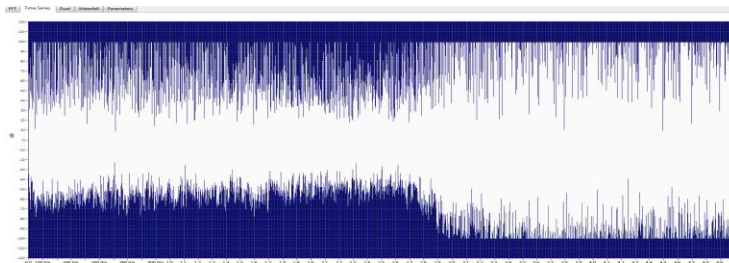
Frequency Domain Analysis

Audio Analysis => **High level abnormal ultrasound was detected**

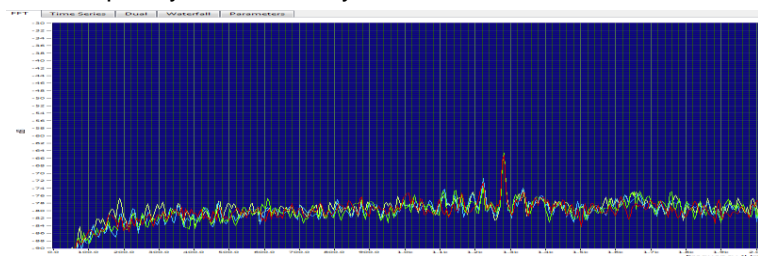
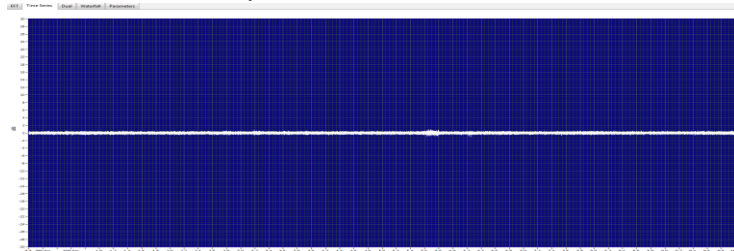
Frequency Domain Analysis

Audio Analysis => **No Abnormal ultrasound was detected.**

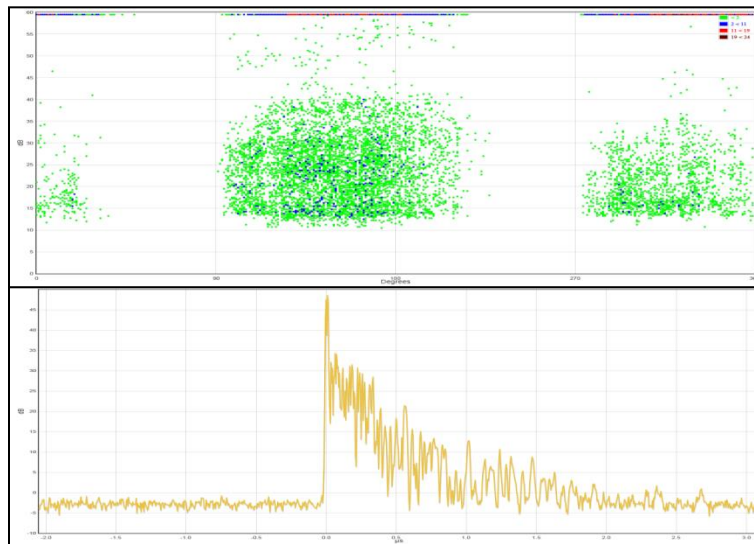
Phase Resolved TEV

(Before replacement of terminations on 02nd Nov 2016)

Observation : Partial Discharge at the Cable Termination of the Blue Phase.

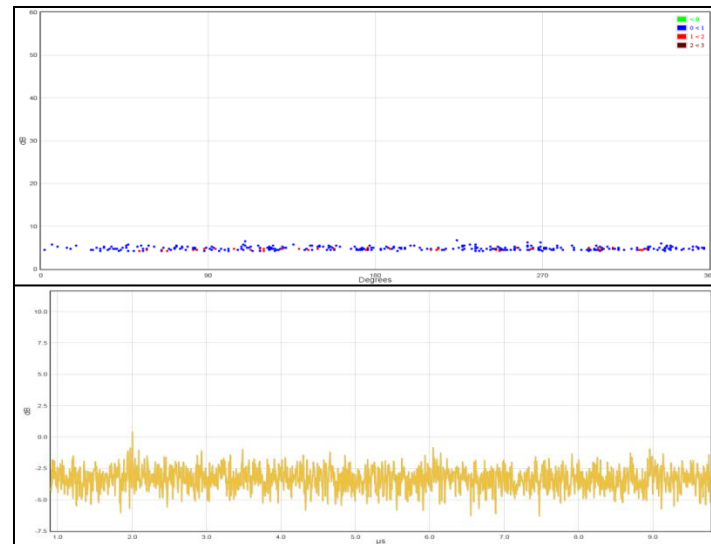
Phase Resolved TEV

(After replacement of terminations on 10 Jan 2017)

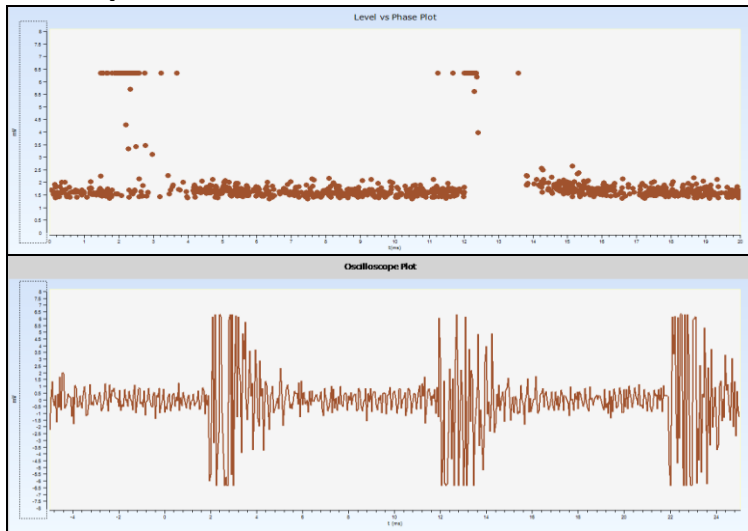
Phase Resolved Ultrasound
(Before replacement of terminations on 02nd Nov 2016)

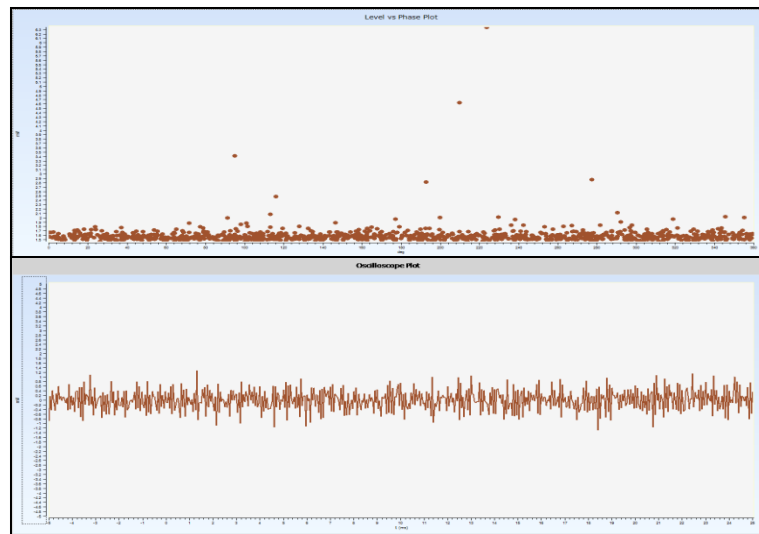
Phase Resolved Ultrasound
(After replacement of terminations on 10 Jan 2017)

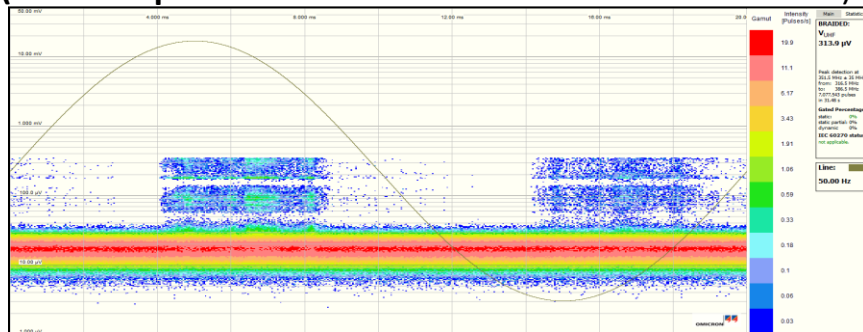
Phase Resolved UHF
(Before replacement of terminations on 02nd Nov 2016)

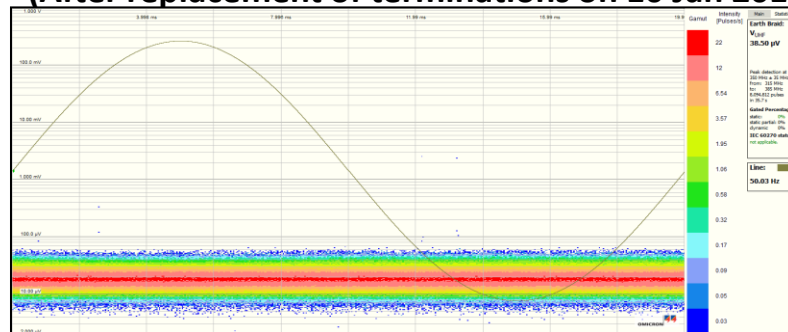
Phase Resolved UHF
(After replacement of terminations on 10 Jan 2017)

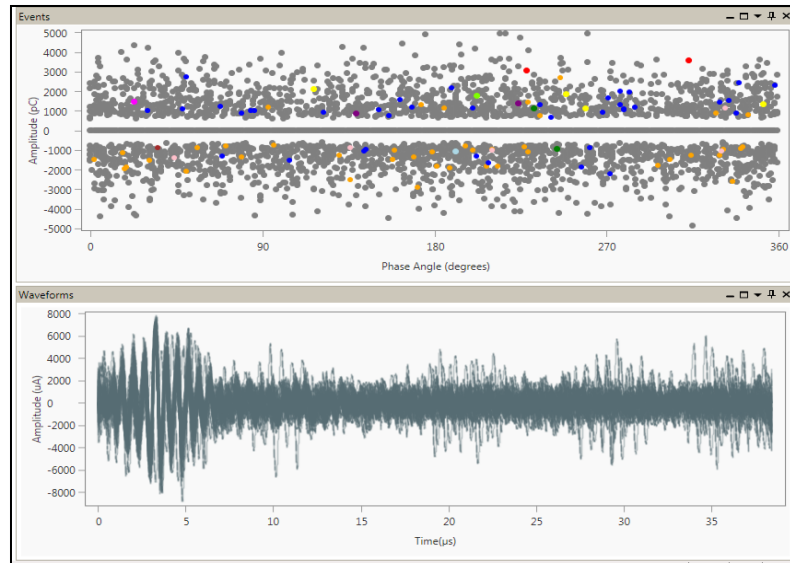
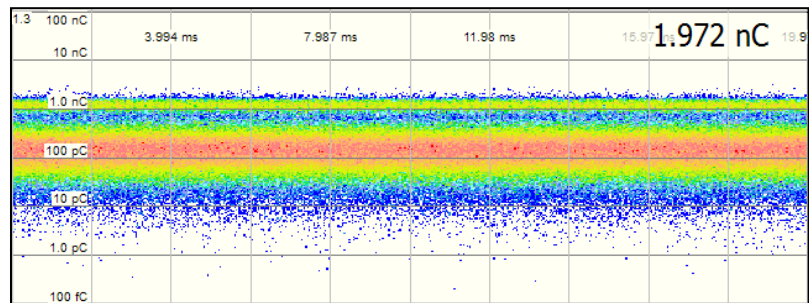
(After replacement of terminations on 10 Jan 2017)

Phase Resolved HFCT
(After replacement of terminations on 10 Jan 2017)

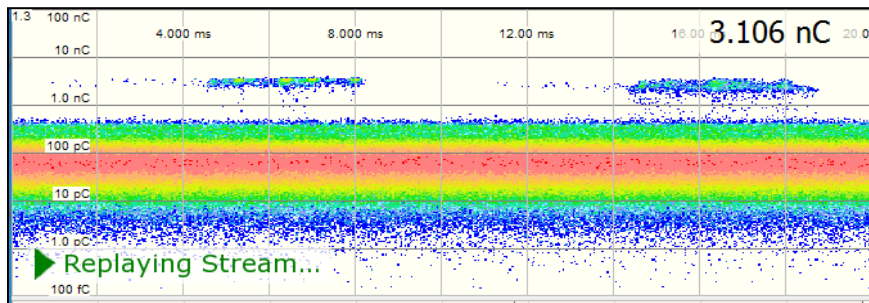
(Before replacement of terminations on 02nd Nov 2016)

Phase Resolved HFCT
(Before replacement of terminations on 02nd Nov 2016)

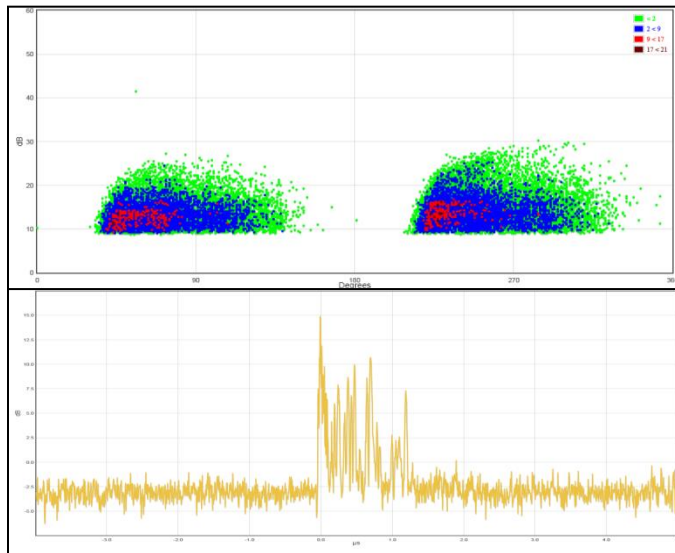
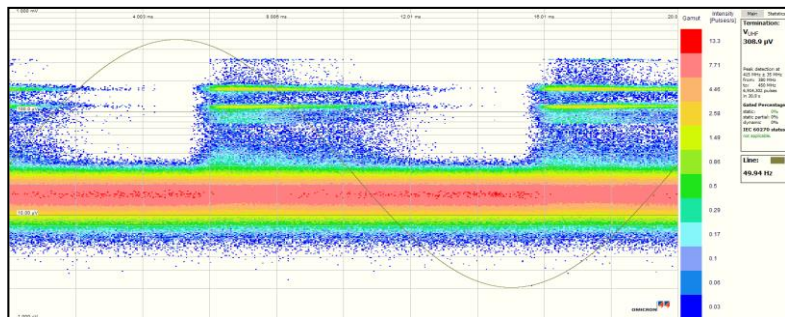
(Before replacement of terminations on 18th May 2017)

Phase Resolved UHF
(Before replacement of terminations on 18th May 2017)

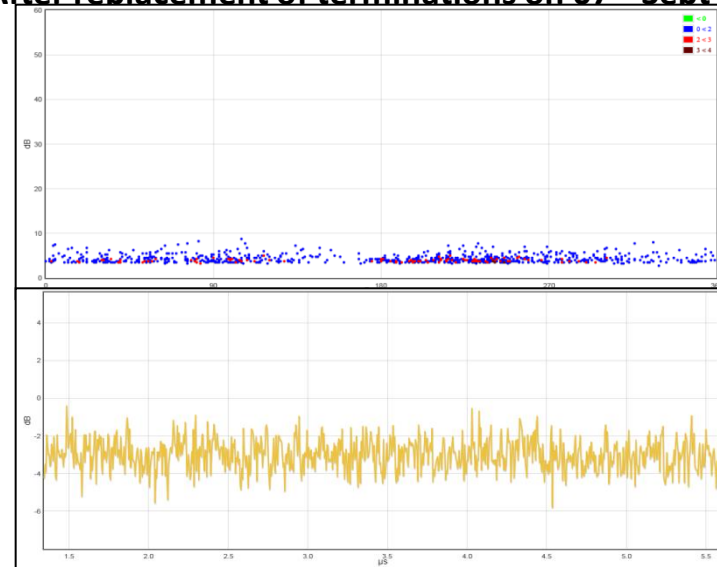
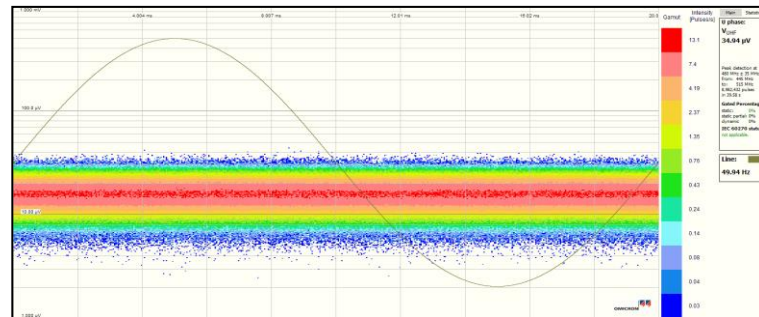
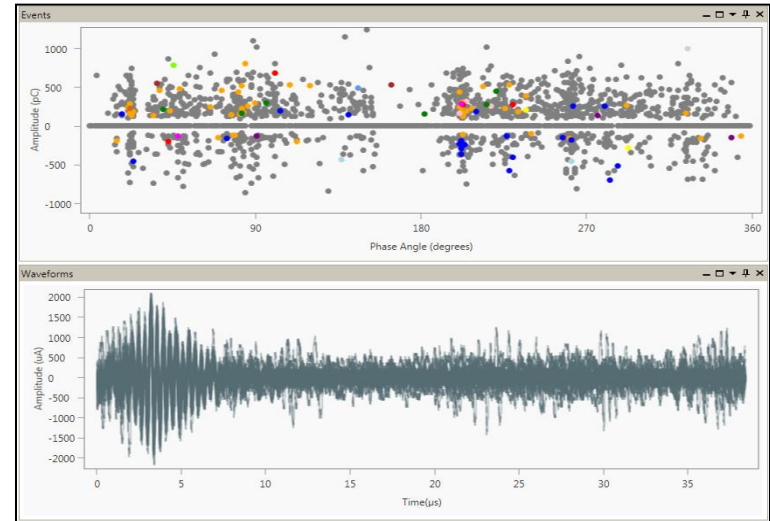
(After replacement of terminations on 07th Sept 2017)

Phase Resolved UHF
(After replacement of terminations on 07th Sept 2017)

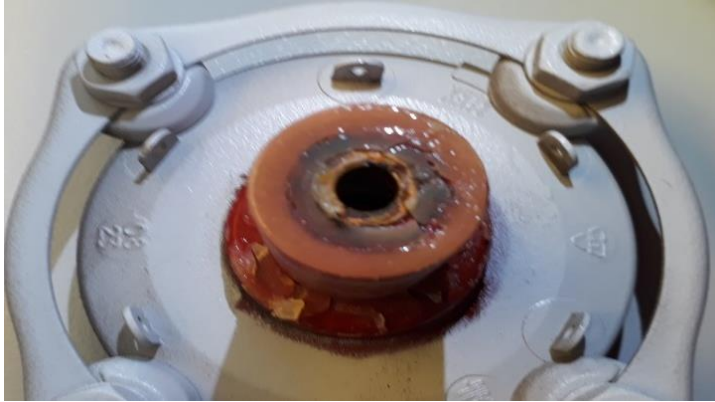
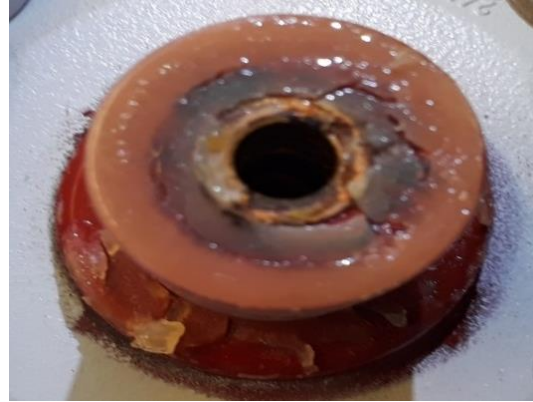
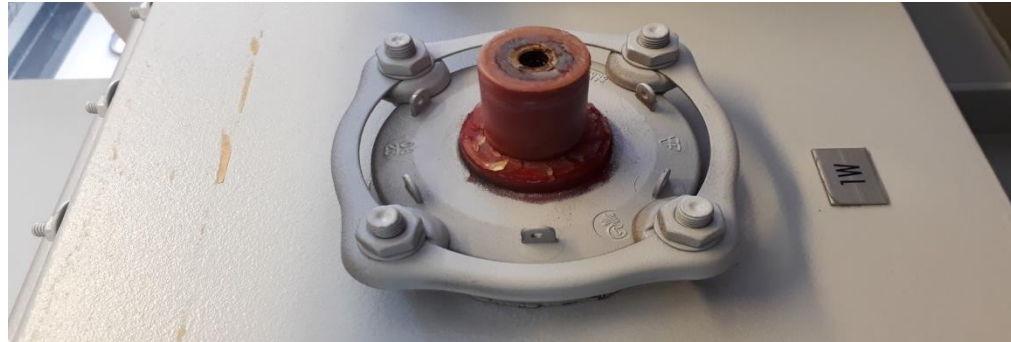
Photos of PD during SDM

Observation : During Shutdown, Rust was found at the 22kV cable termination.

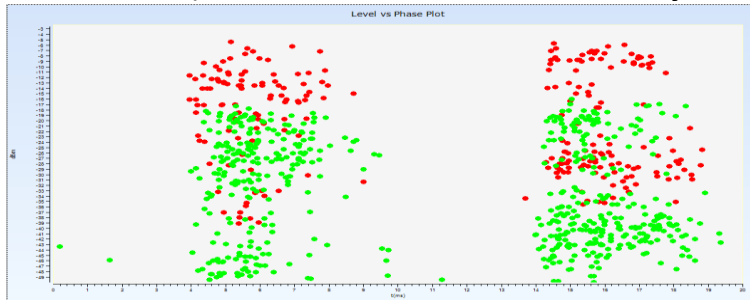
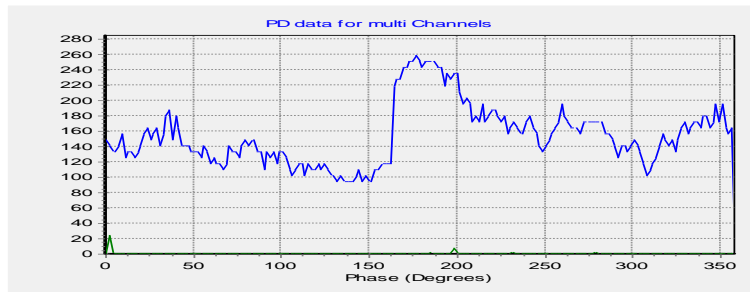
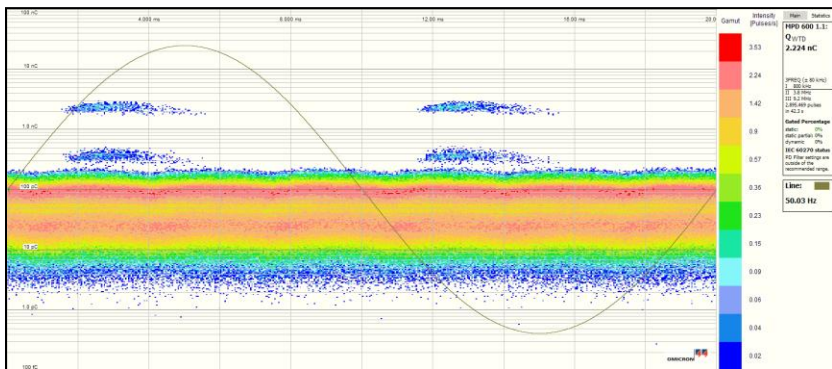
Phase Resolved TEV
(BEFORE ISOLATING VT2 on May 2018)

Phase Resolved HFCT
(BEFORE ISOLATING VT2 on May 2018)

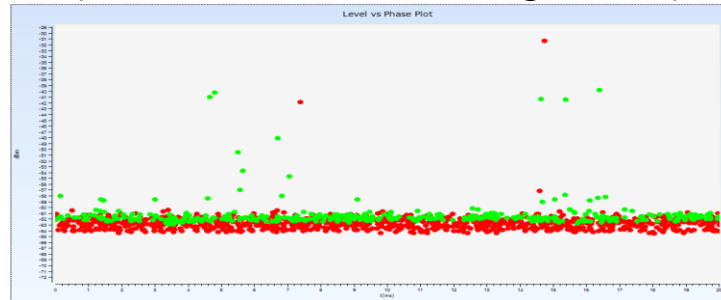
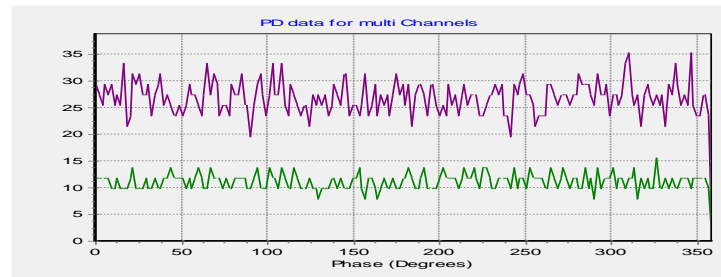
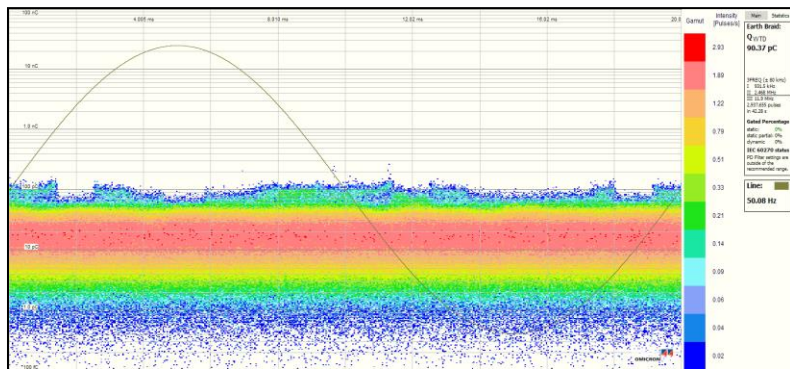
Phase Resolved TEV
(AFTER ISOLATING VT2 on August 2018)

Phase Resolved HFCT
(AFTER ISOLATING VT2 on August 2018)

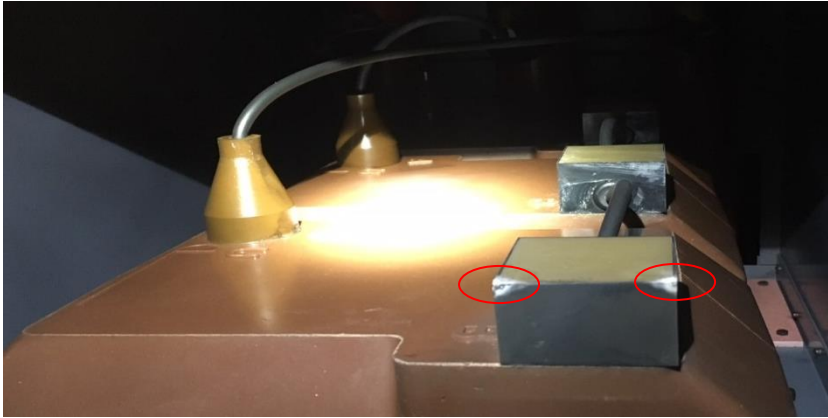
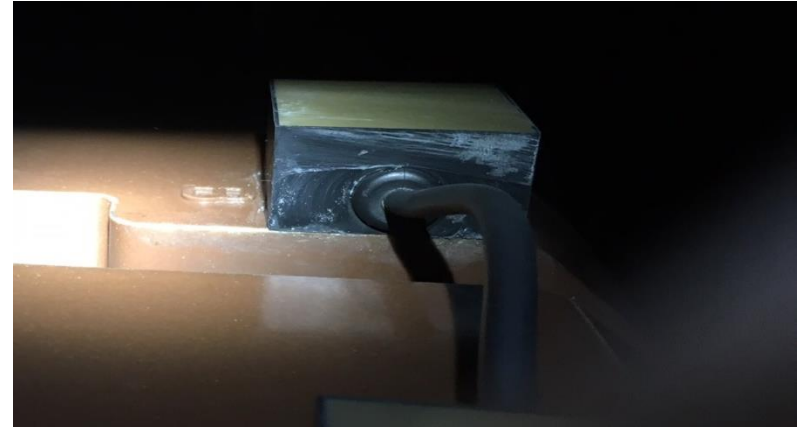
Photos of PD during SDM

Observation : Visible crack at 22kV VT.

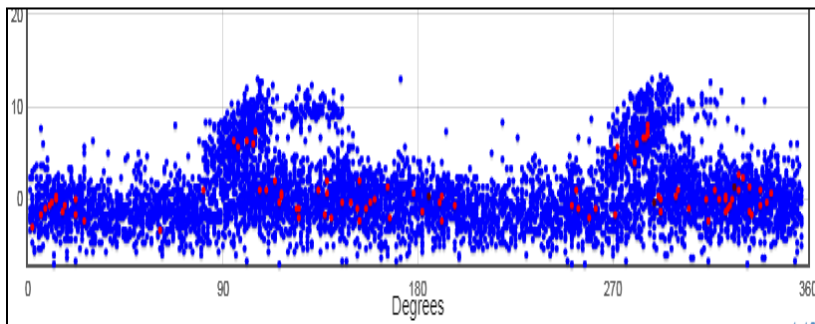
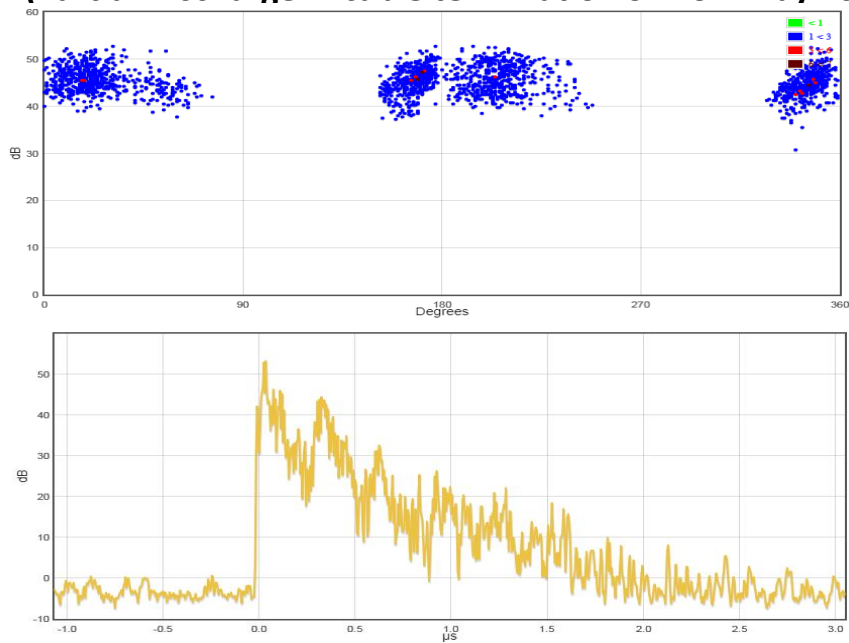
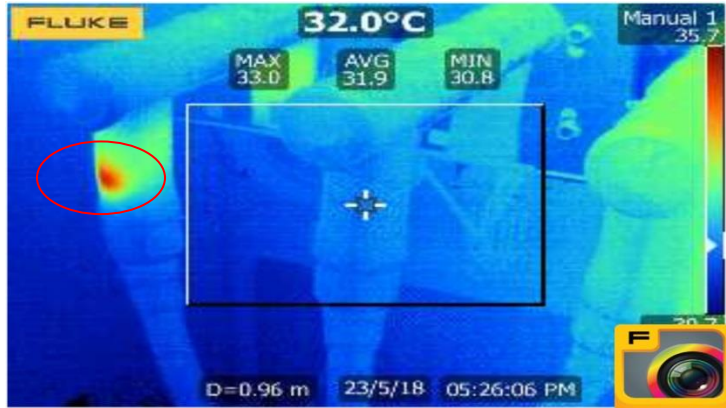
Phase Resolved Ultrasound
(Partial Discharge in cable termination on 19th May 2018)

Phase Resolved HFCT
(Partial Discharge in cable termination on 19th May 2018)

Phase Resolved TEV
(Partial Discharge in cable termination on 19th May 2018)

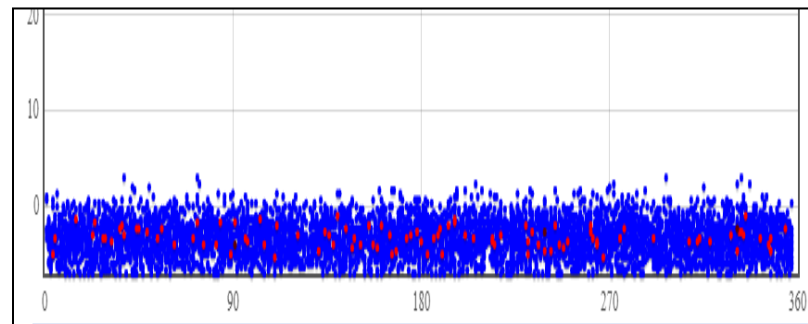
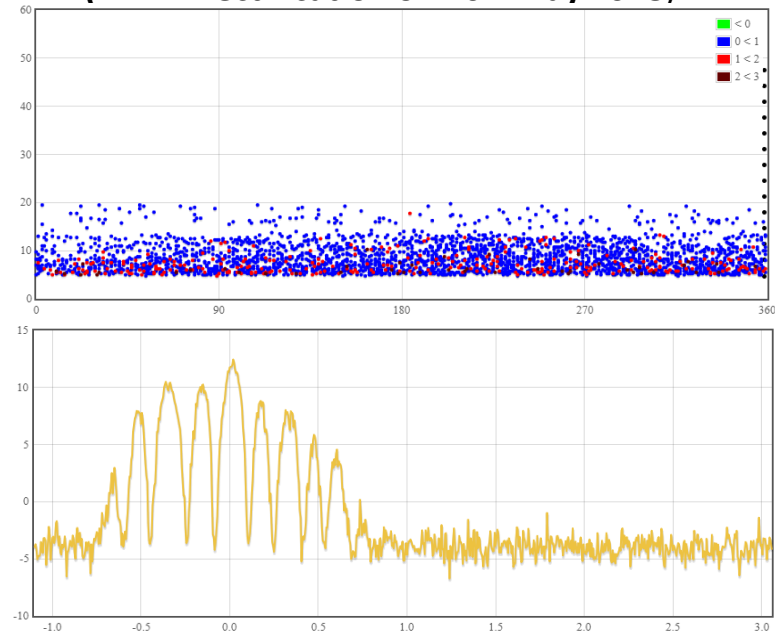
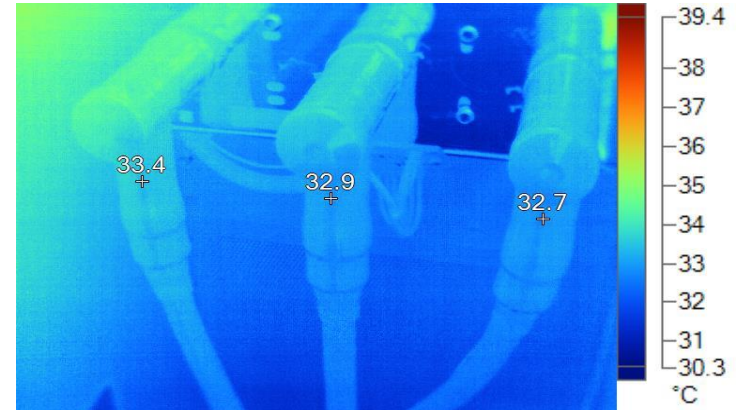
Phase Resolved Ultrasound
(AFTER Rectification on 26th May 2018)

Phase Resolved HFCT
(AFTER Rectification on 26th May 2018)

Phase Resolved TEV
(AFTER rectification on 26th May 2018)

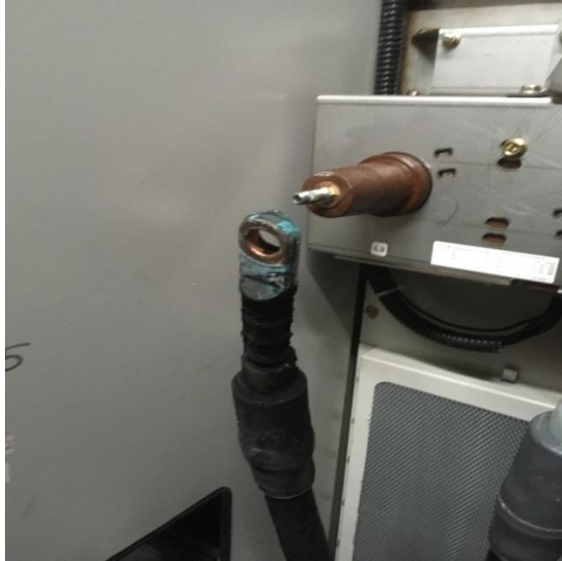
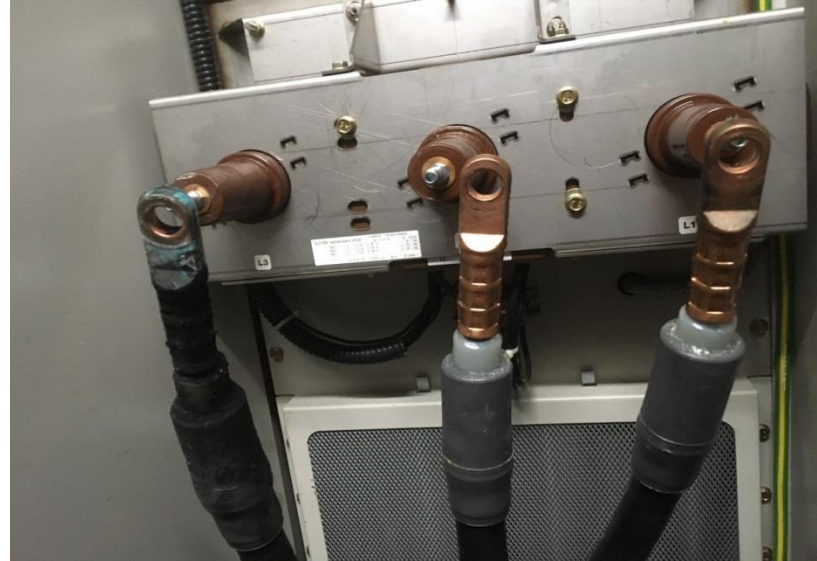
Photos of PD during SDM

Observation : Partial discharge was found at the cable lug of L3 with green discoloration.
