22kV cable termination, outer cone type

Asset: Cable lug of 22kV cable termination, outer cone type

PD sensor: Infra-Red thermal scan, ultrasound, TEV & HFCT

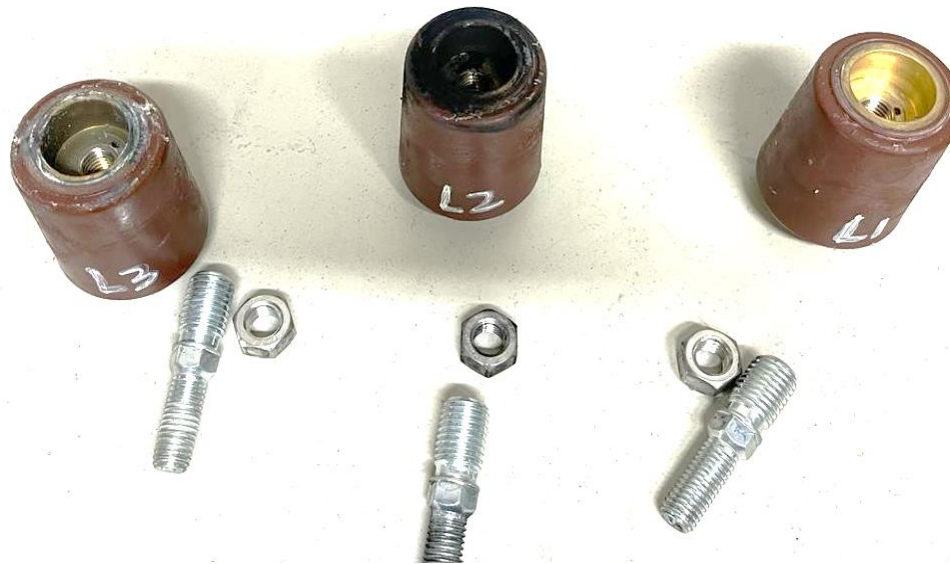
Visible discharge at Cable lug

29 November 2022 (0900 Hrs) PD activity was detected at 22kV cable termination of GIS using multiple PD sensor and Infra-Red thermal scanning.

29 November 2022 (2000 Hrs) The circuit was de-energized on the same day. PD was found at 22kV cable termination.

30 November 2022 Online PD re-measurement was done after replacement of cable terminations. No PD activity found.
